Sub: Regarding status report of discharge of RO Reject and RO Reject accumulation outside the premises on land by the textile process houses located at Bhilwara.

STATUS REPORT

TEXTILE PROCESS HOUSES

LOCATED AT BHILWARA

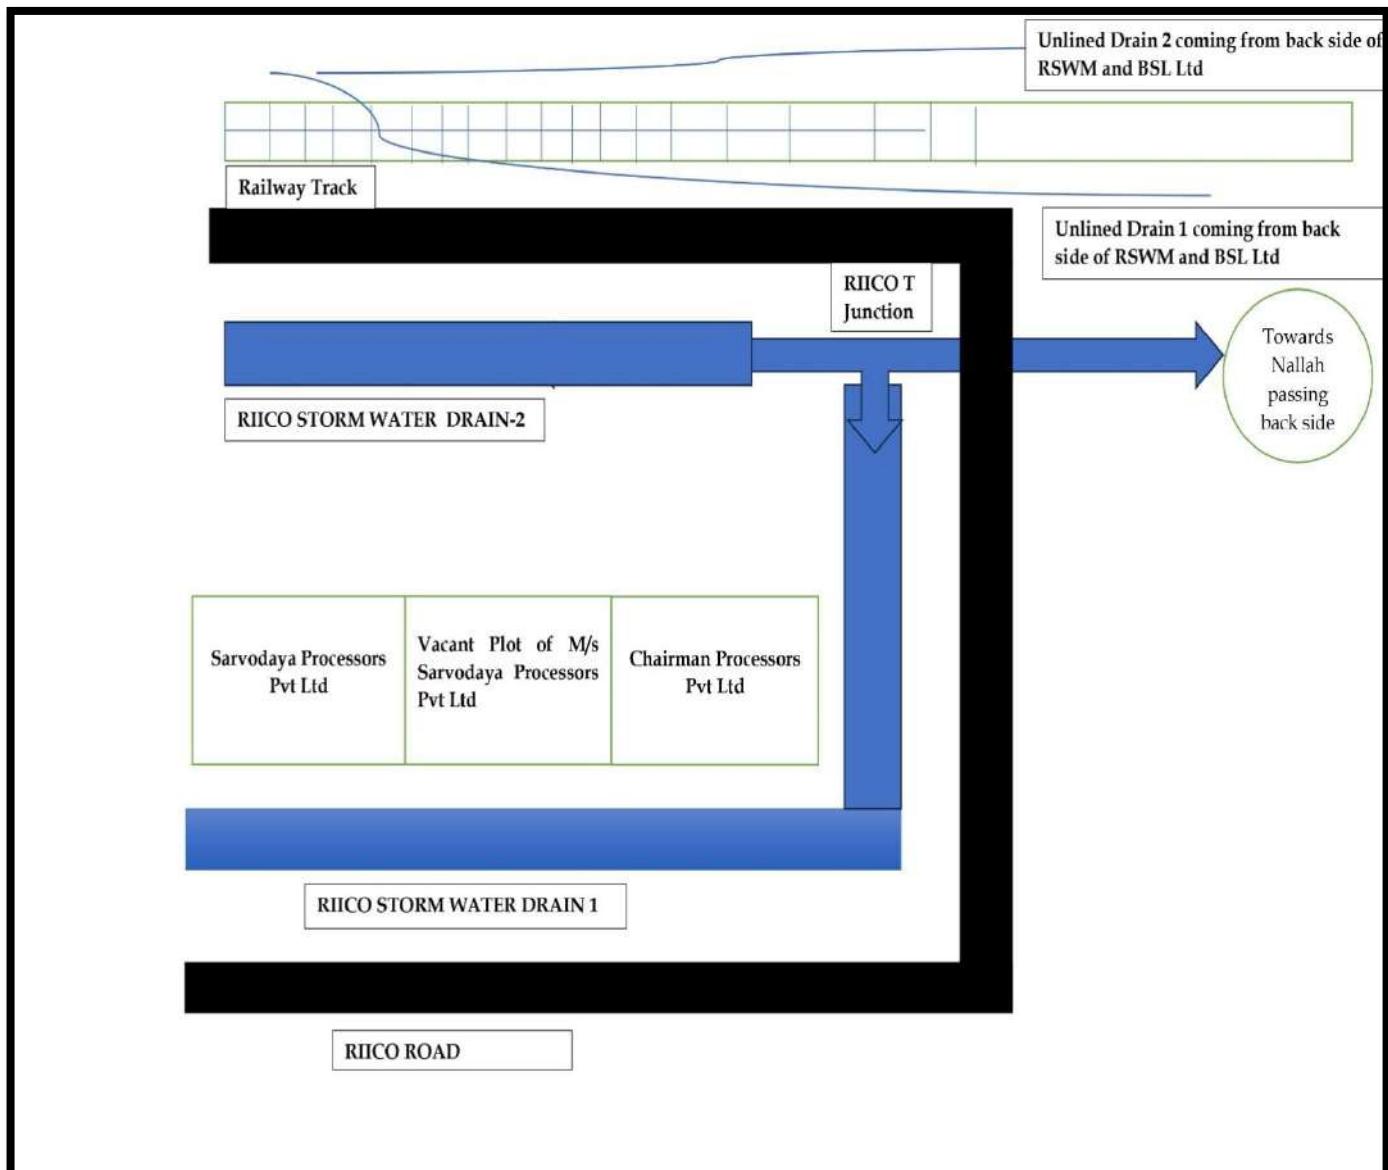
Figure 1 Drainage Pattern at RIICO T Junction (Check Point No.1)

Detailed sketch map of RIICO T Junction and drainage pattern is as under fig 1:-

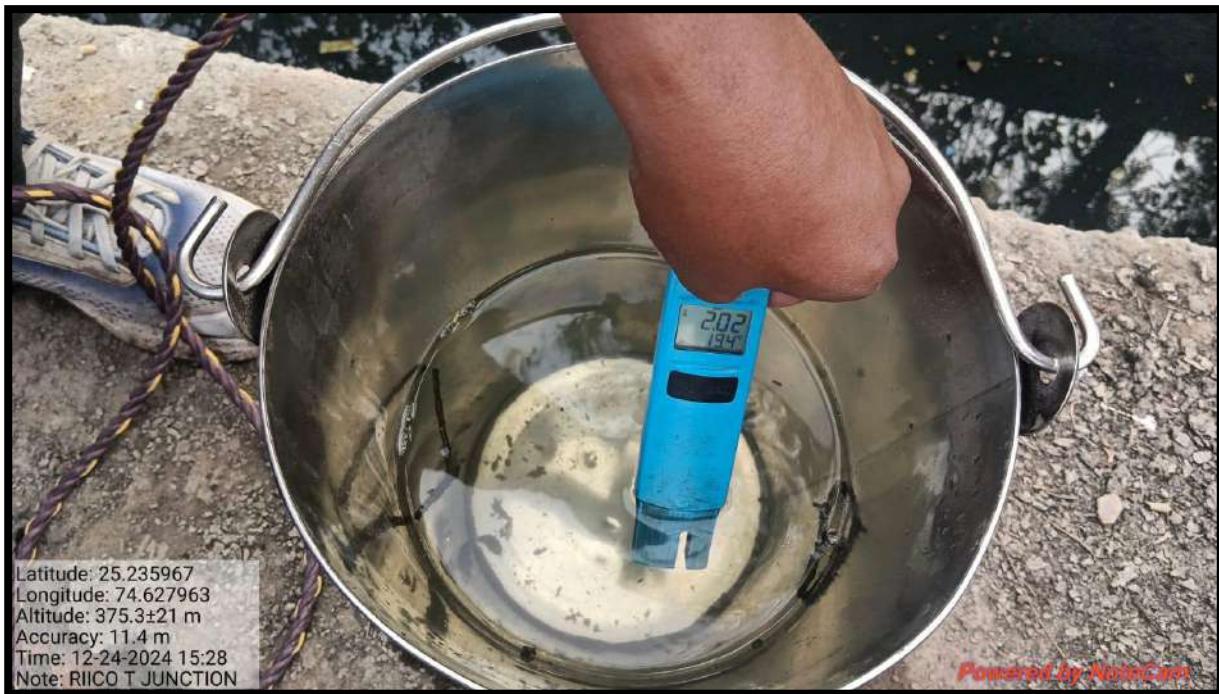
Figure 2- TDS Measurement at Check Point No-1 - RIICO T Junction

During inspection carried out on 24th December 2024 at check point No.1, no High TDS effluent was observed at RIICO T Junction. TDS measure at this check point was 2020 mgpl, which indicates that, there is no high TDS Effluent was being discharged by these two process houses.

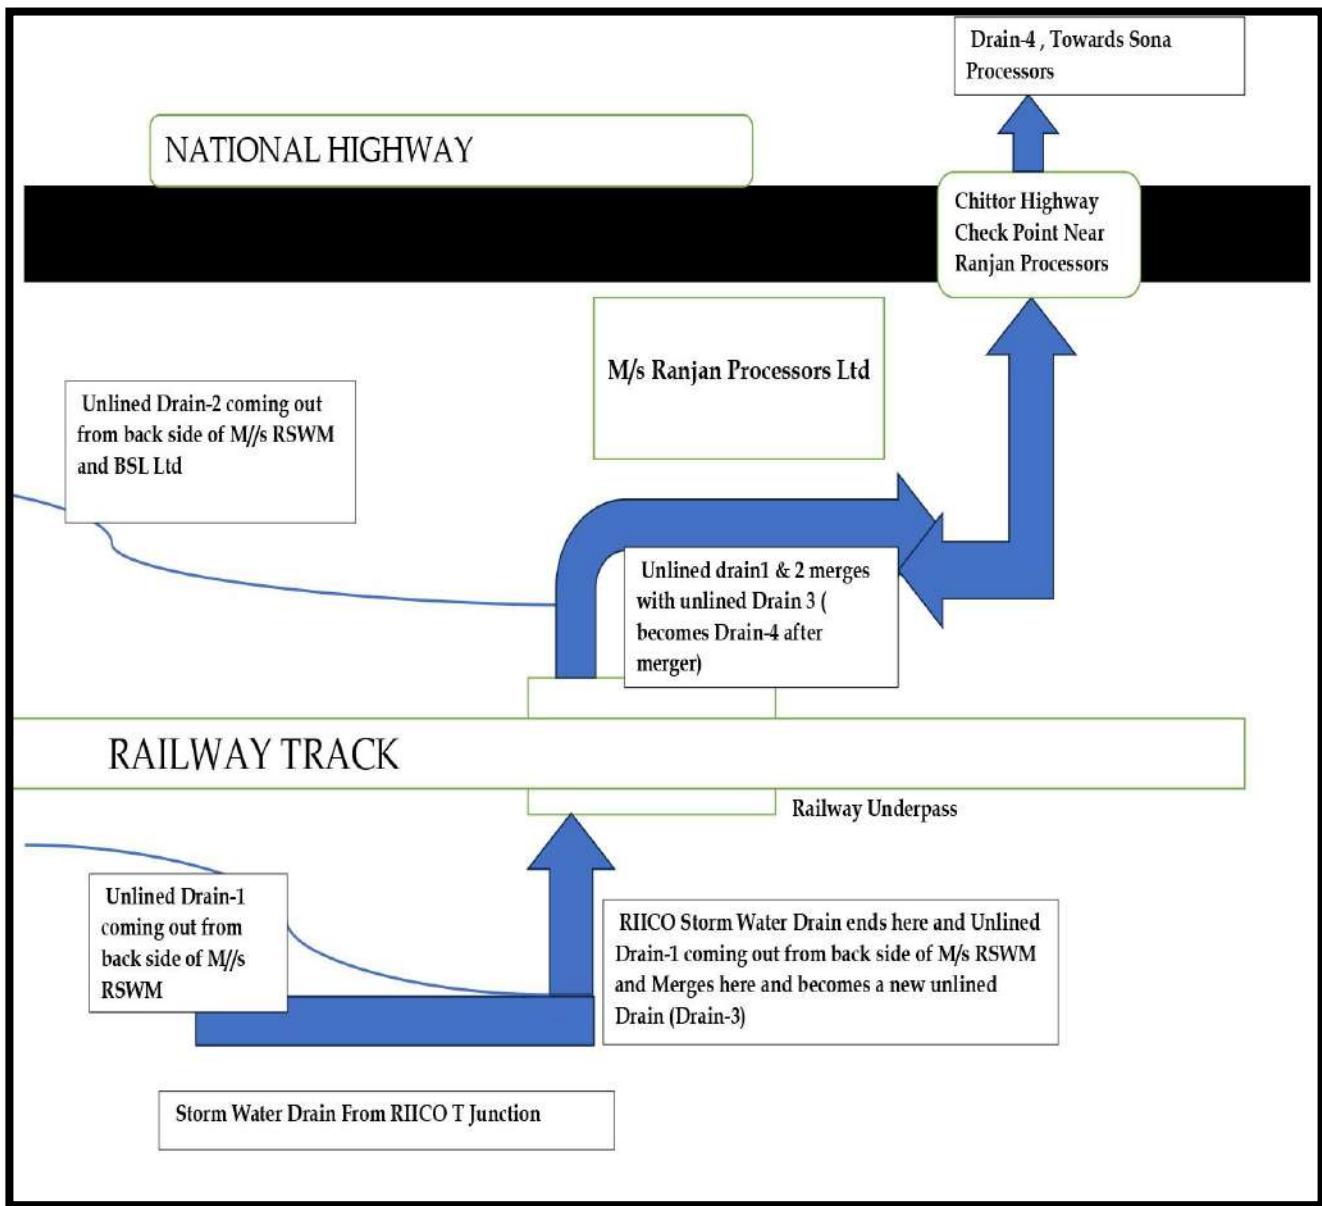
Figure 3- Drainage Pattern at Check Point No.2

In case no unusual activity observed at Check Point 1 , TDS of check point 2 is being measured and in case there is high TDS observed at check point no. 2 , it can be inferred that there is some discharge related activity is being done either through drain 1 or through drain 2 which originates from M/s RSWM Ltd and M/s BSL Ltd.

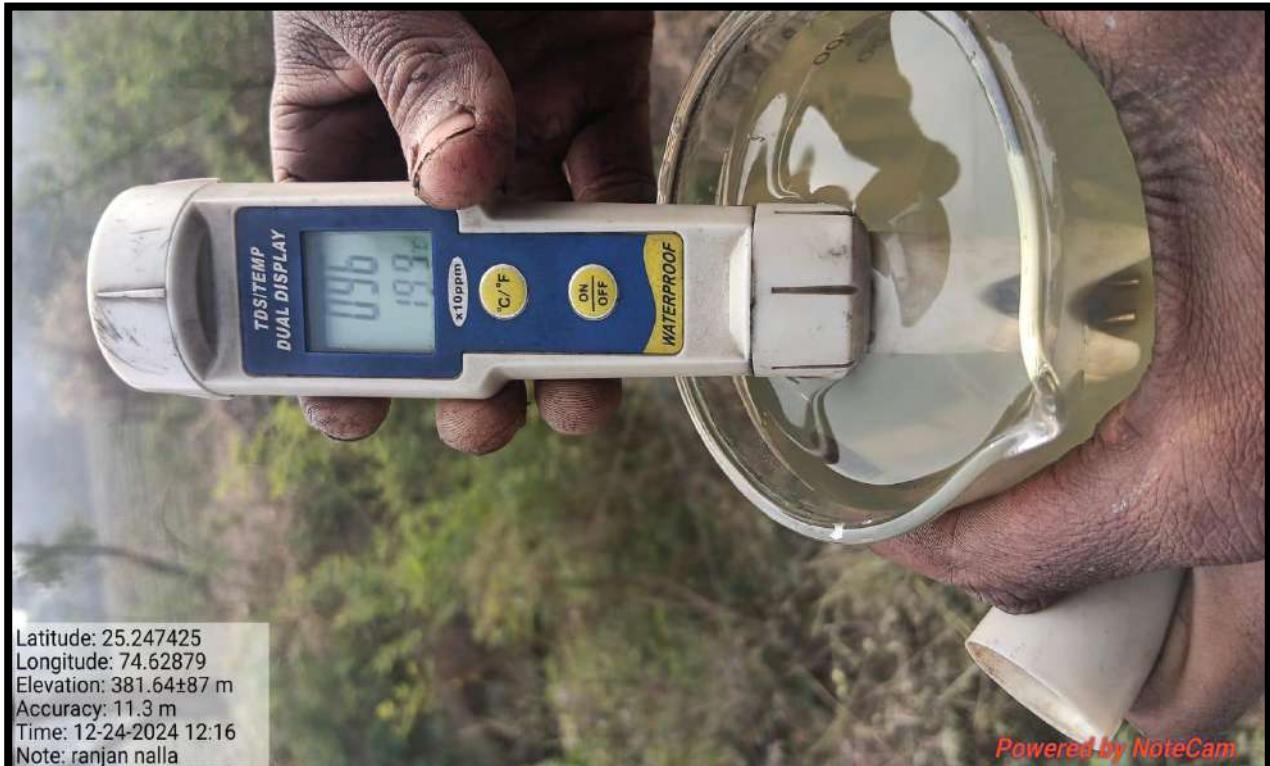
Figure 4- TDS at Check Point No 2 - Drain Near Ranjan Processors

During inspection carried out on 24th December 2024, at check point No.2, no High TDS effluent was observed at this point. TDS measured at this check point was 960 mgpl, which inferred that, there is no high TDS Effluent was being discharged by these three process houses.

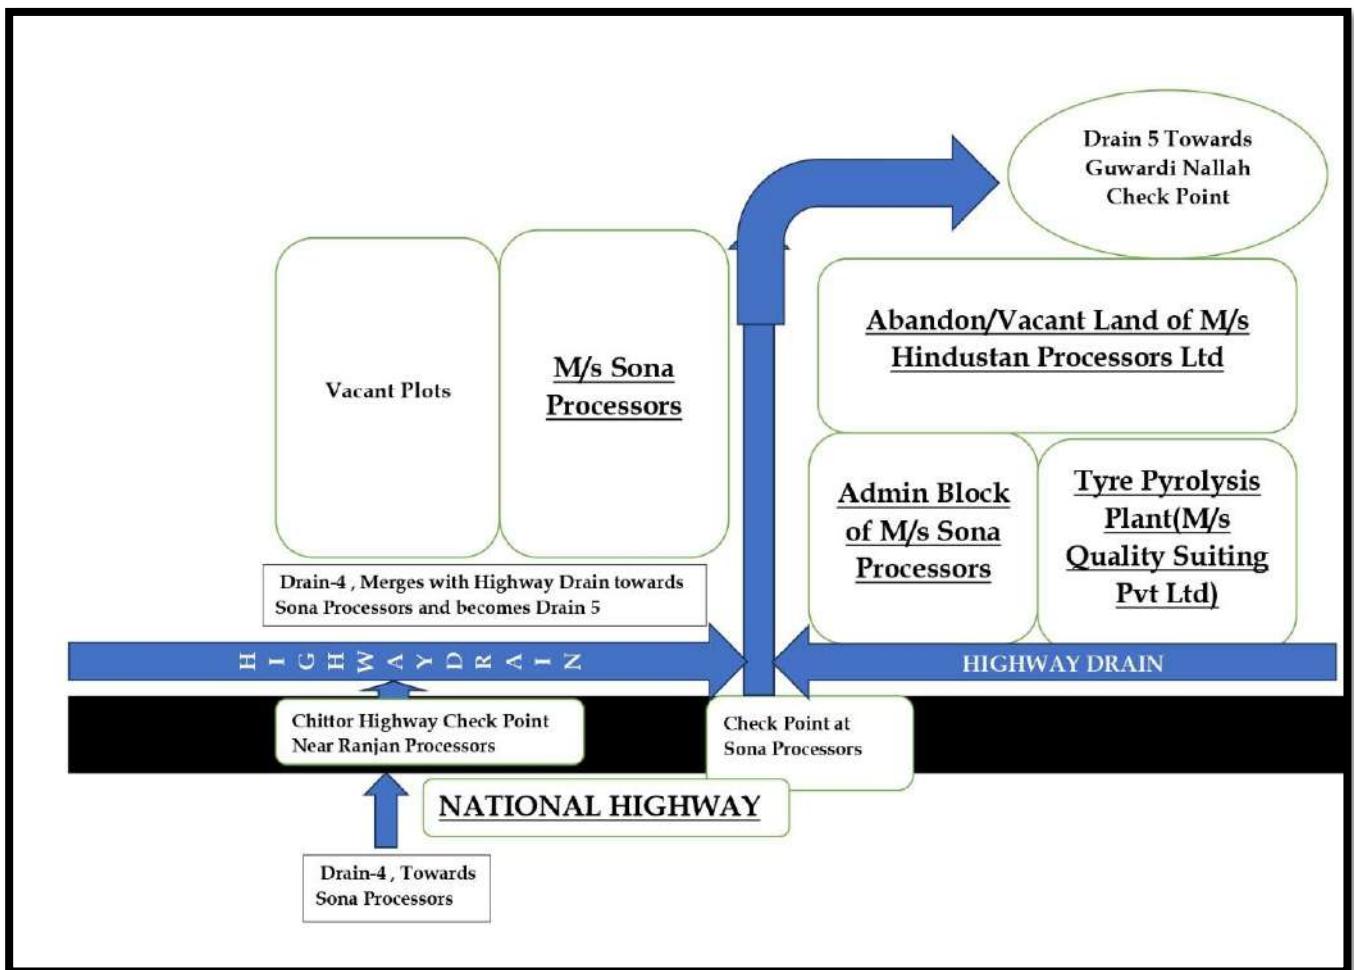
Figure 5 Drainage Pattern at Check Point No.3

Further, from check point No.2 , drain no 4, leads towards M/s Sona Processors and from Check point no.2 it got mixed with Highway Drain coming from M/s Sanwariya Texfab and M/s Puja Spintex outside the vacant plot adjacent to M/s Sona Processors Ltd and ultimately lead towards M/s Sona Processors and marked herein as Drain No.5. A the boundary between M/s Sona Processors and Admin building of M/s Sona Processors, Check Point No.3 has been identified from where Drain 5 moves and further leads to Guwardi Nalah. In case there is no High TDS observed at Both Check Point No1 and Check Point No.2 and High TDS effluent observes at Check Point No.3 , it can be inferred as M/s Sona Processors is indulged in discharging activity.

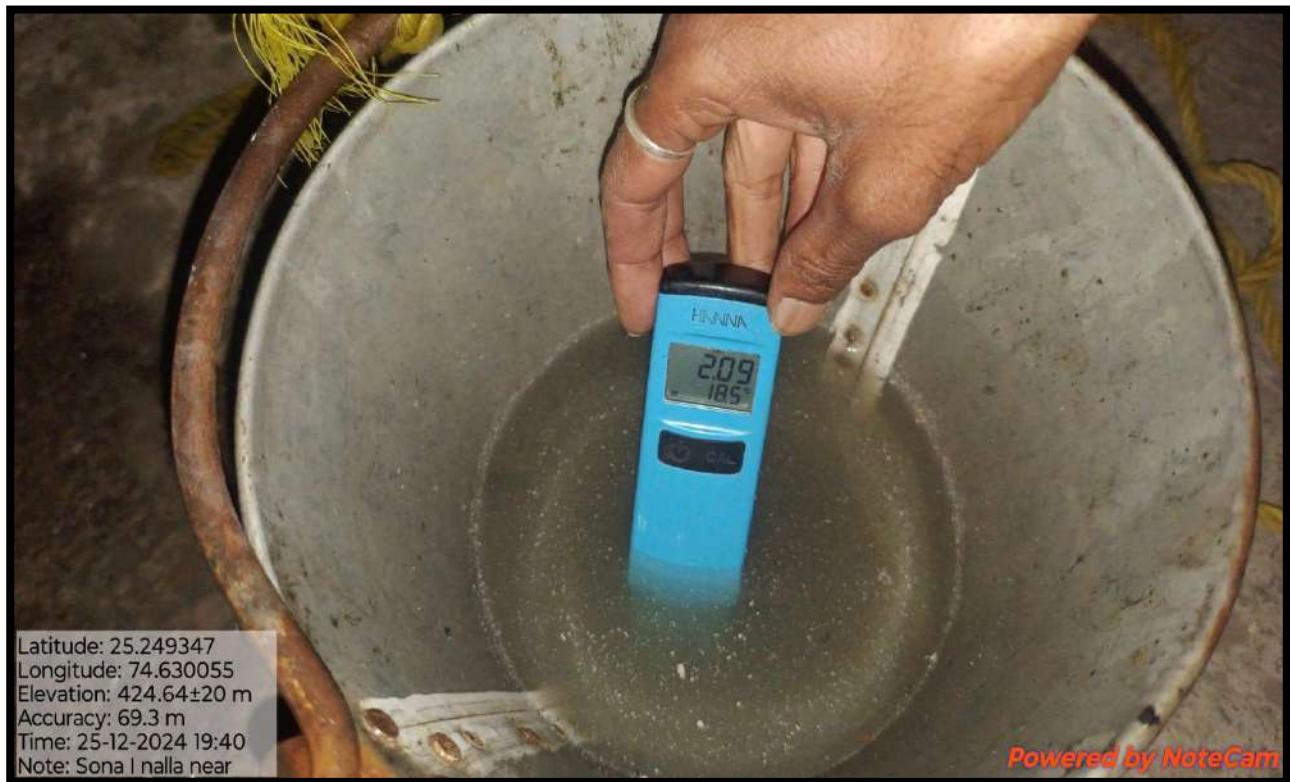
Figure 6 - TDS measurement at Check Point No3 - M/s Sona Processors Ltd

During inspection carried out on 25th December 2024, at check point No.3, no High TDS effluent was observed at this point. TDS measured at this check point was 2090 mgpl, which inferred that, there is no high TDS Effluent was being discharged by M/s Sona Processors.

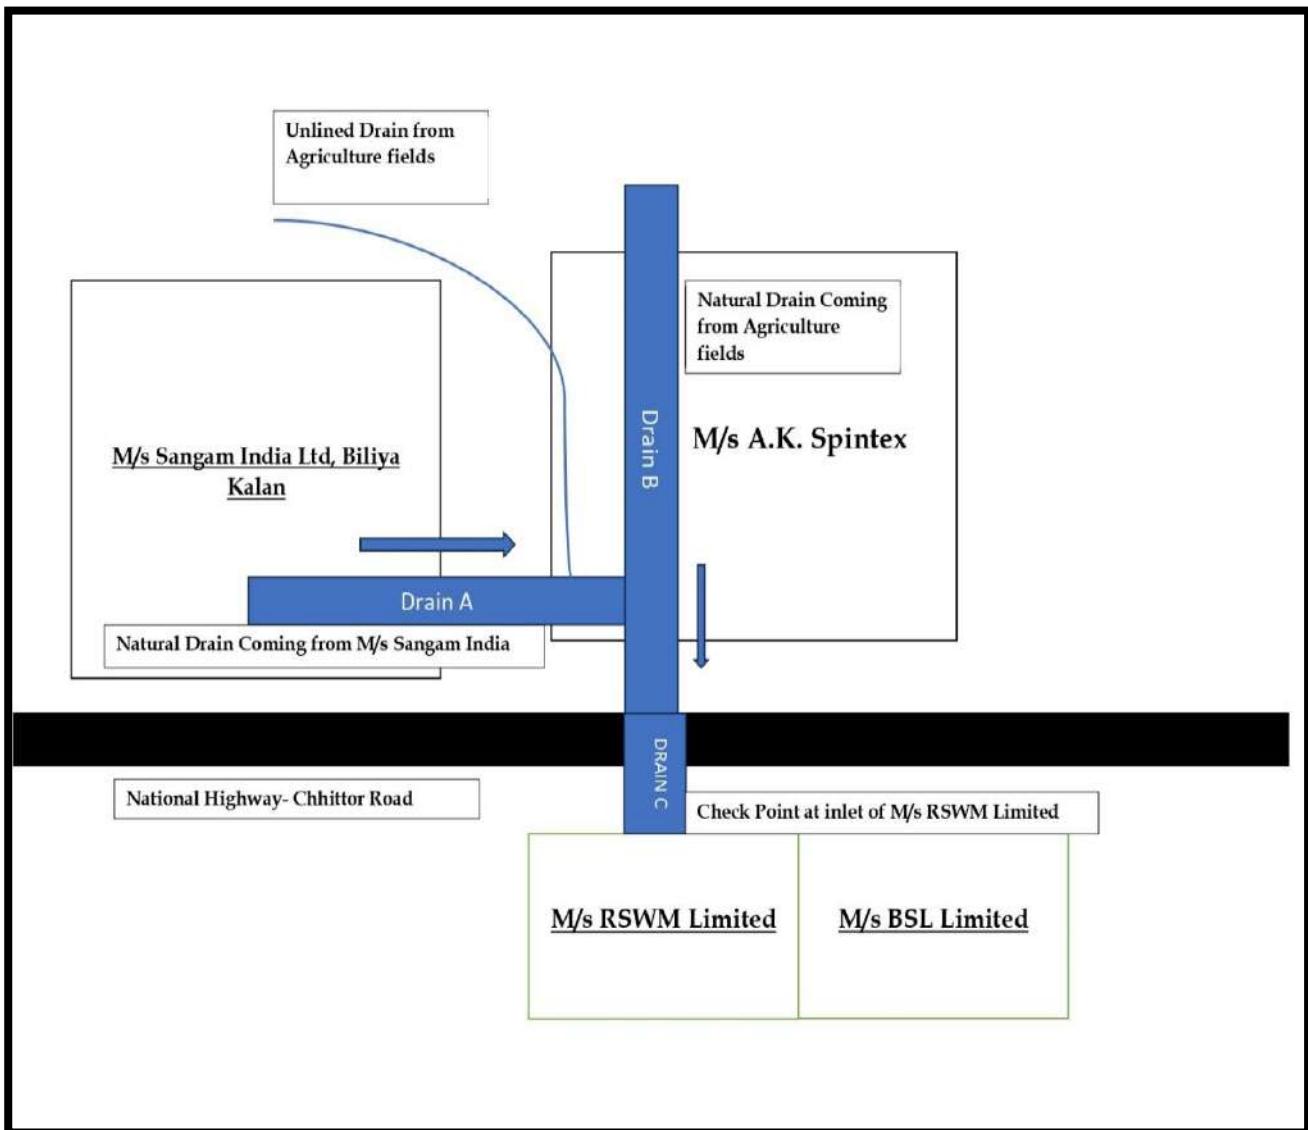
Figure 7 Drainage Pattern at Check Point No.4

This drain, marked as Drain C, enters into the RSWM premises and passes through the premises in between the process area and MEE/ETP area and further exit the premises of M/s RSWM through back end of its boundary and enters to the gap area between M/s RSWM Ltd and M/s BSL Ltd.

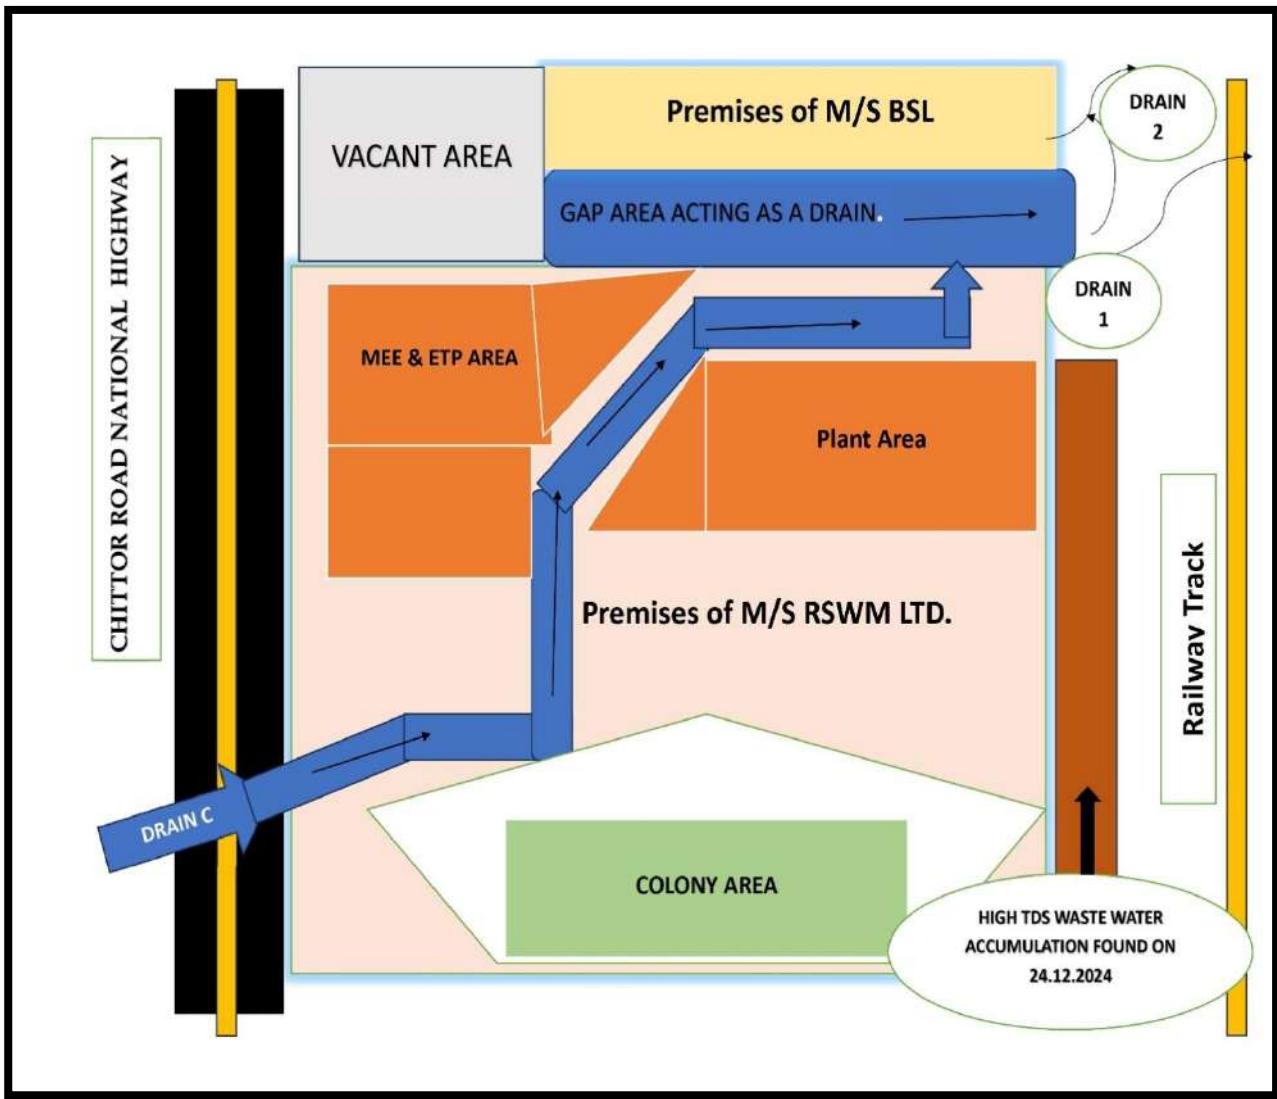
Figure 8 Drainage Pattern within the premises of M/s RSWM Mandapam

This gap area acts as a drain and unlined drain 1 and drain 2 originated from this point as mentioned at Check Point No.1 and Fig.1.

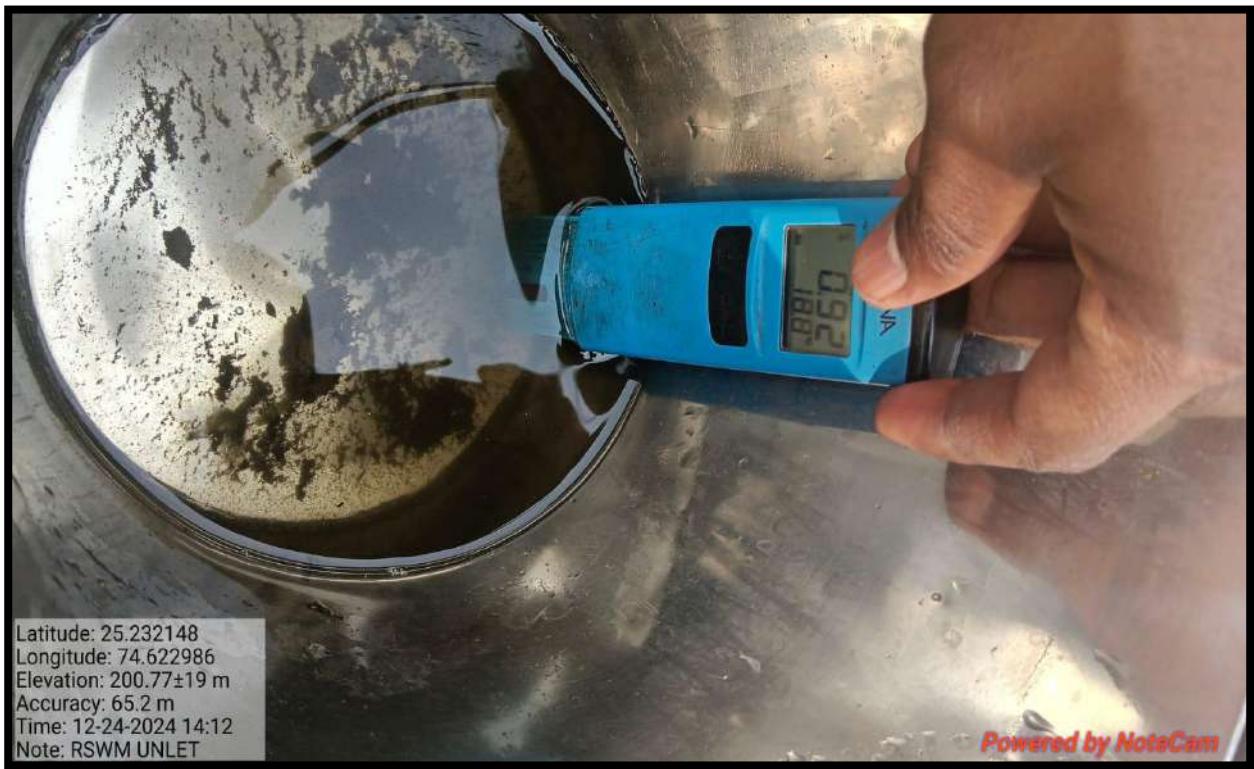
Figure 9- TDS measurement at Check Point No 4- Inlet of M/s RSWM Ltd, Mandapam, Bhilwara

During inspection carried out on 24th December 2024, at check point No.4, no High TDS effluent was observed at this point. TDS measured at this check point was 920 mgpl, which inferred that, there is no high TDS Effluent was being discharged either by M/s Sangam India Ltd or M/s AK Spintex.

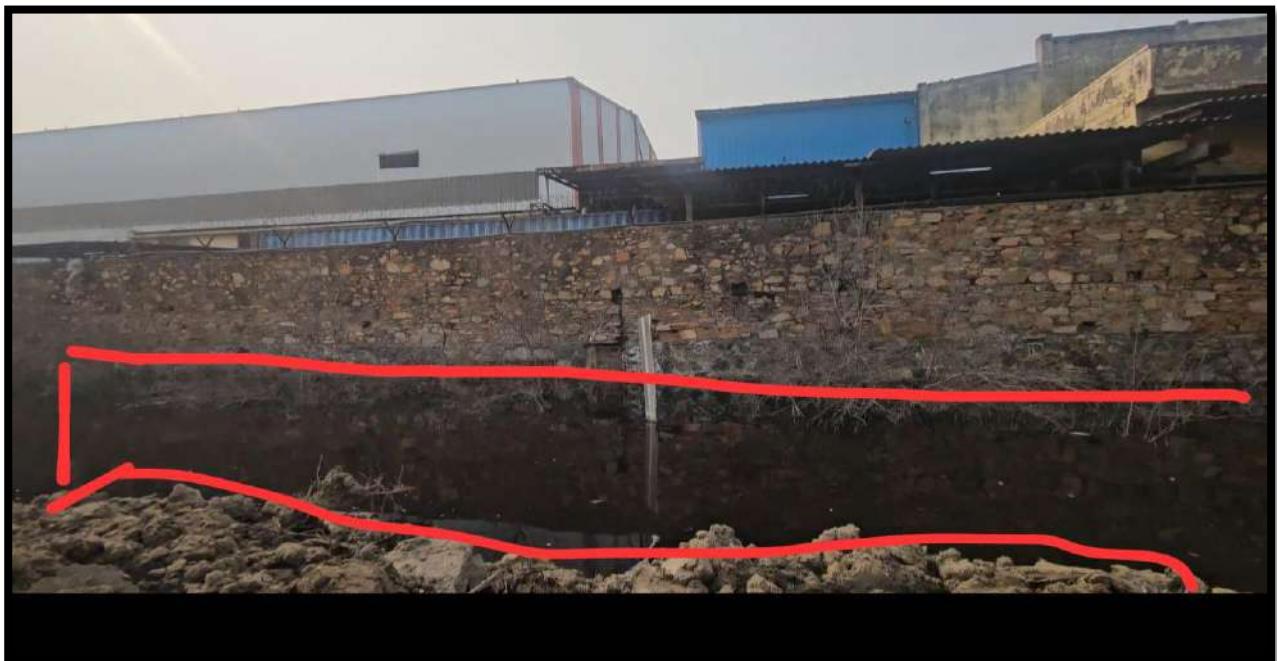
Further, huge amount of High TDS effluent was found accumulated on an open shallow land of dimensions approx. 900 ft (L) X 13 ft (W) X 2.5 Ft (Depth). This area was found surrounded by kachha boundary wall, due to which it was not found flowing from that area and if this quantity of effluent with High TDS(10000 mgpl, maximum limit of handy hydron TDS meter), allowed to flow, it will raise the TDS of entire water flowing through various check points through drain 1 and drain 2, which ultimately leads to Guwardi Nallah(Check Point No.5), leading to Banas River.

Figure 10- Area where High TDS Effluent accumulated

ACTION TAKEN:-This open land waste water accumulation outside the premises of M/s RSWM Ltd was observed earlier too and reported to HO time to time by this office. Previously, vide this office letter dated 26.06.2024, it was also flagged and detailed report of this unit was sent to HO, mentioning the fact that, High TDS (10000 mgpl, maximum limit of handy hyna TDS meter) effluent was accumulated at the same area. At that time, dimesnsion of unlined kachha pit was reported as 311.59 mtr(L) X 23.28 mtr(width) X 1.0 mtr (Depth).

Further, in various reports sent by this office , it has been categorically mentioned that , unit may be directed by HO , to lift this High TDS effluent, which is surely RO Reject, back to MEE and dispose it in a scientific manner. (Copy of all such reports are enclosed herewith as Annexure)

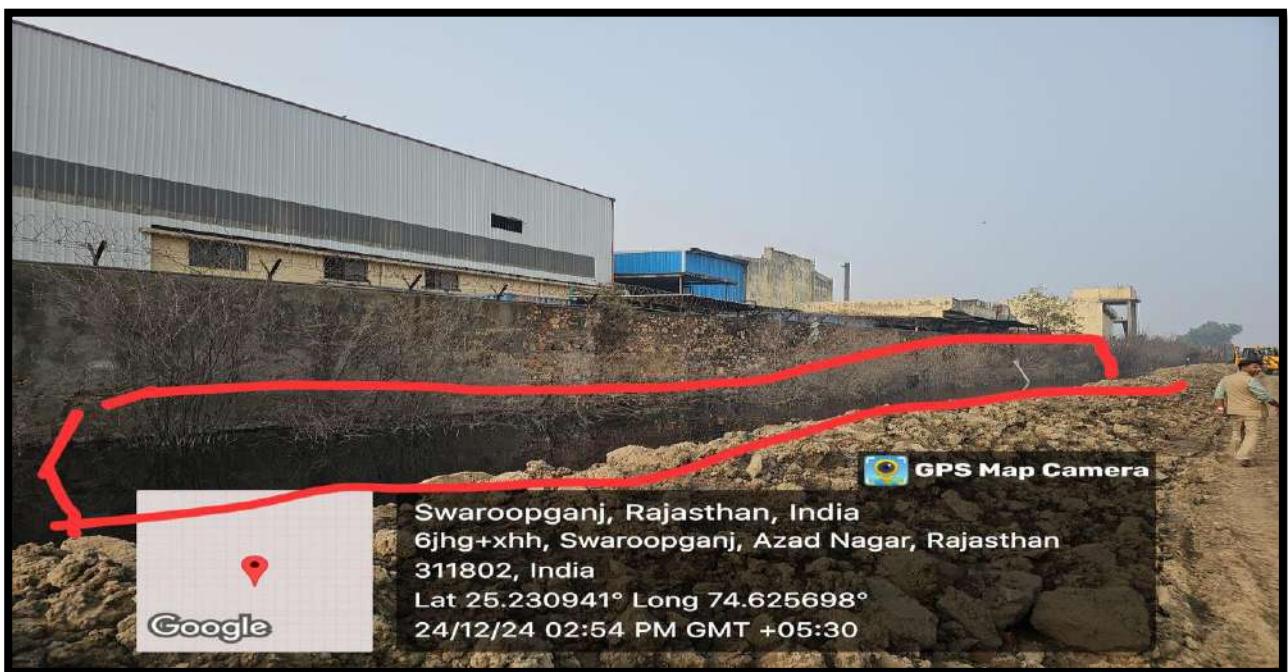
Figure 11- Stretch where High TDS Effluent was found accumulated behind M/s RSWM Ltd

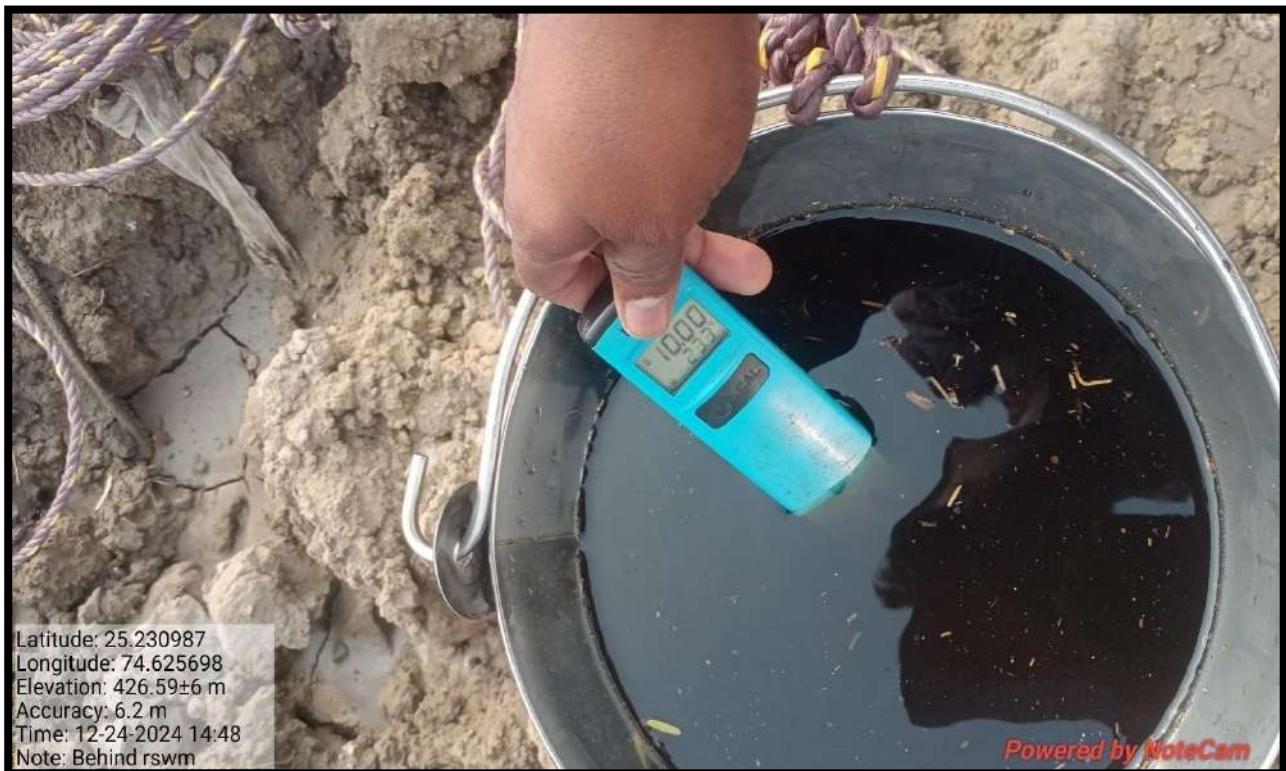
Figure 12 TDS of Effluent accumulated on back side area of M/s RSWM Ltd Mandapam

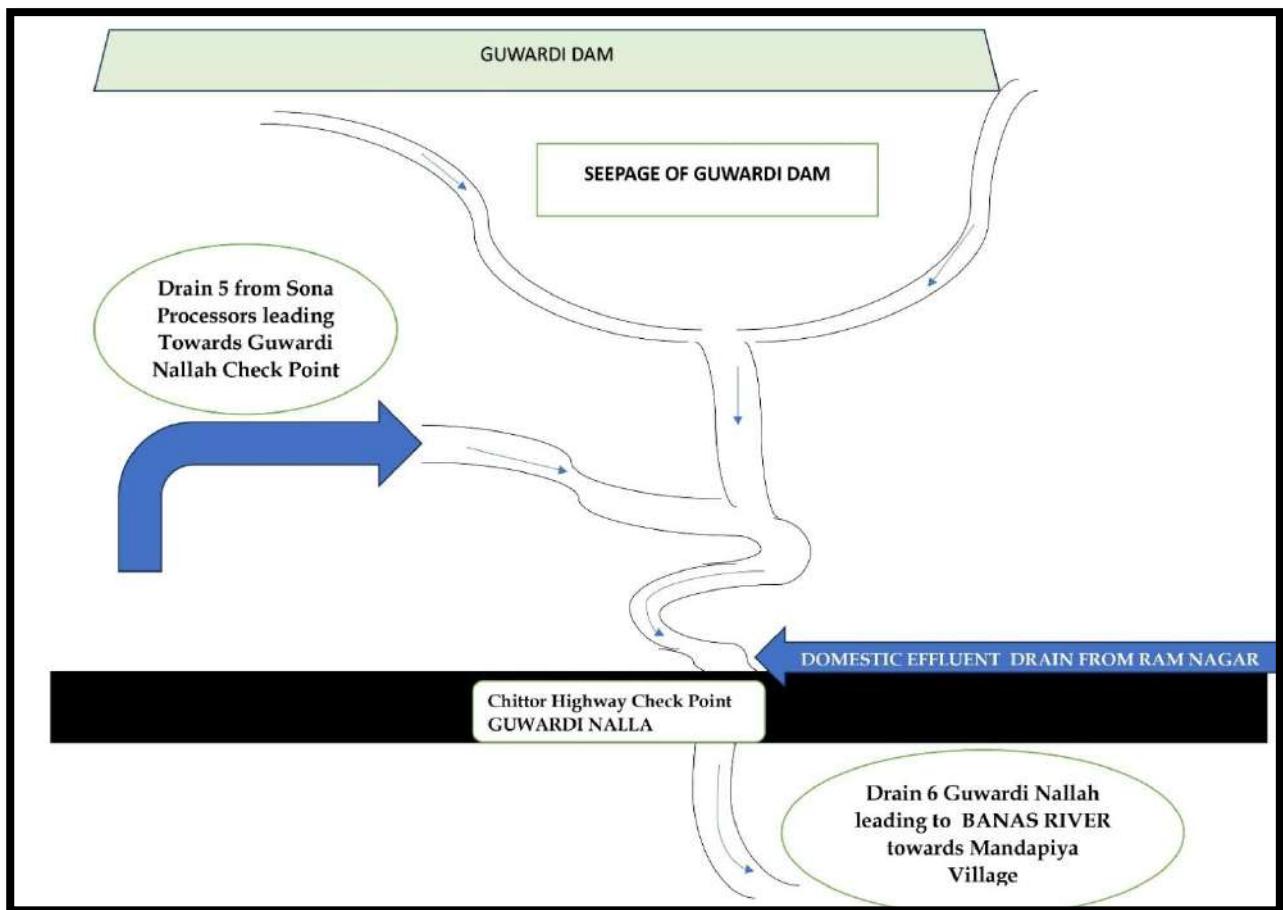
Figure 13 Drainage Pattern of Guwardi Nallah.

5. Vigilance Pattern and Modus Operandi followed for Check Point located on Guwardi Nallah, Chittor highway Puliya, Marked as Check Point No. 5 :- Guwardi Nallah is the last check point, marked as Check Point No.5, of the process houses located at Chittor Road, connected through Natural Drainage Pattern. Guwardi Nallah Area is the confluence area of all the drainage marked as Drain 5, as mentioned in above various check points, along with domestic effluent lines coming from villages/colonies/settlements, located at the upstream of Guwardi Nallah, seepage of Guwardi Dam, and Canal which is allowed to flow in winter season. All the water accumulated at this check point ultimately leads to the Banas River through Drain 6. Drainage Pattern of Guwardi Nallah is as under: -

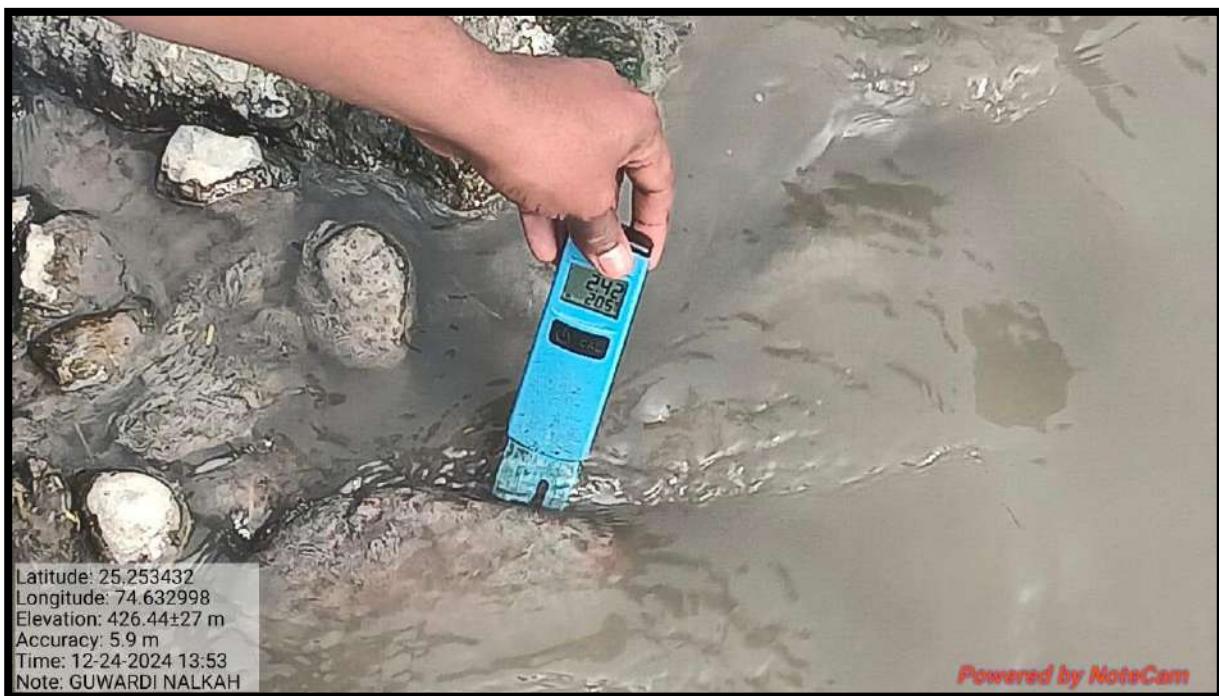
Figure 14- TDS measurement at Guwardi Nallah - Check Point No 5

During inspection carried out on 24th December 2024, at check point No.5, water was found accumulated in the Guwardi Nallah and flow was also observed at this check point. TDS of the accumulated water and flowing water was measured at this check point, which was found to be 2420 mgpl.

Generally, TDS of the RO Reject was found to be around 50000-80000 mgpl (depends on various factors), and TDS observed at Check Point 5 was 2420 mgpl, as such it is primarily inferred that effluent flowing in the Guwardi Nallah was not reject from RO plant.

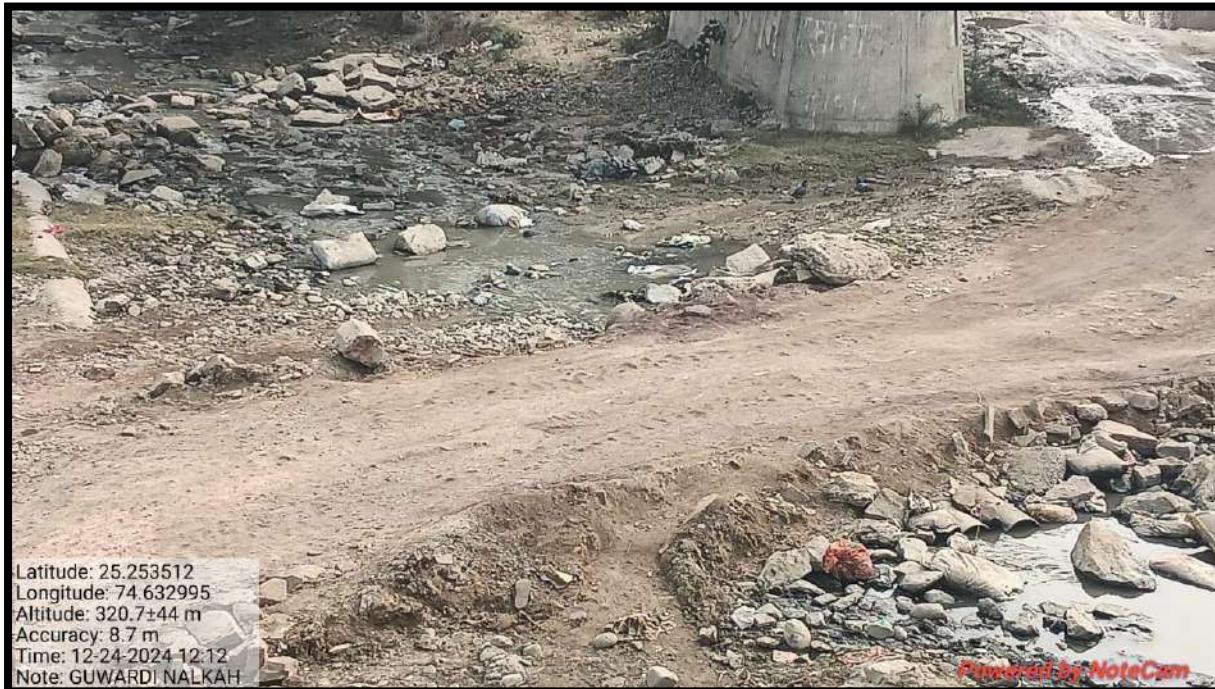
Figure 15-Appearance of Guwardi Nallah - Check Point

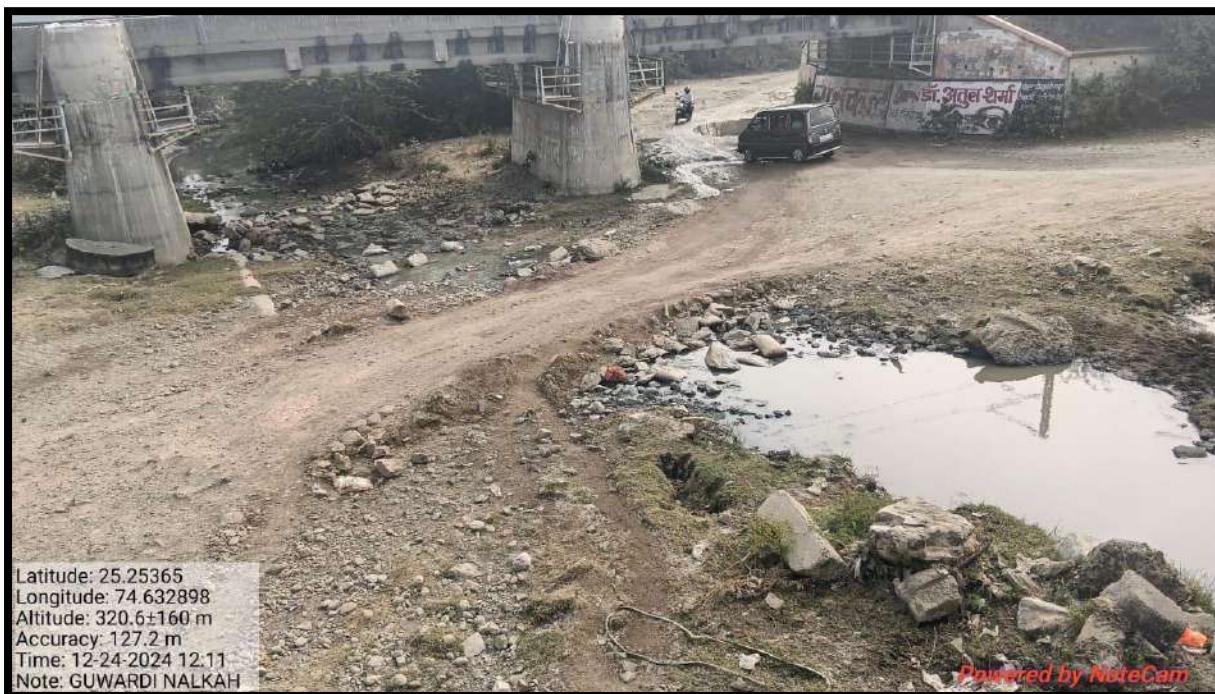
Figure 16 Guwardi Nallah Leading Towards Banas River

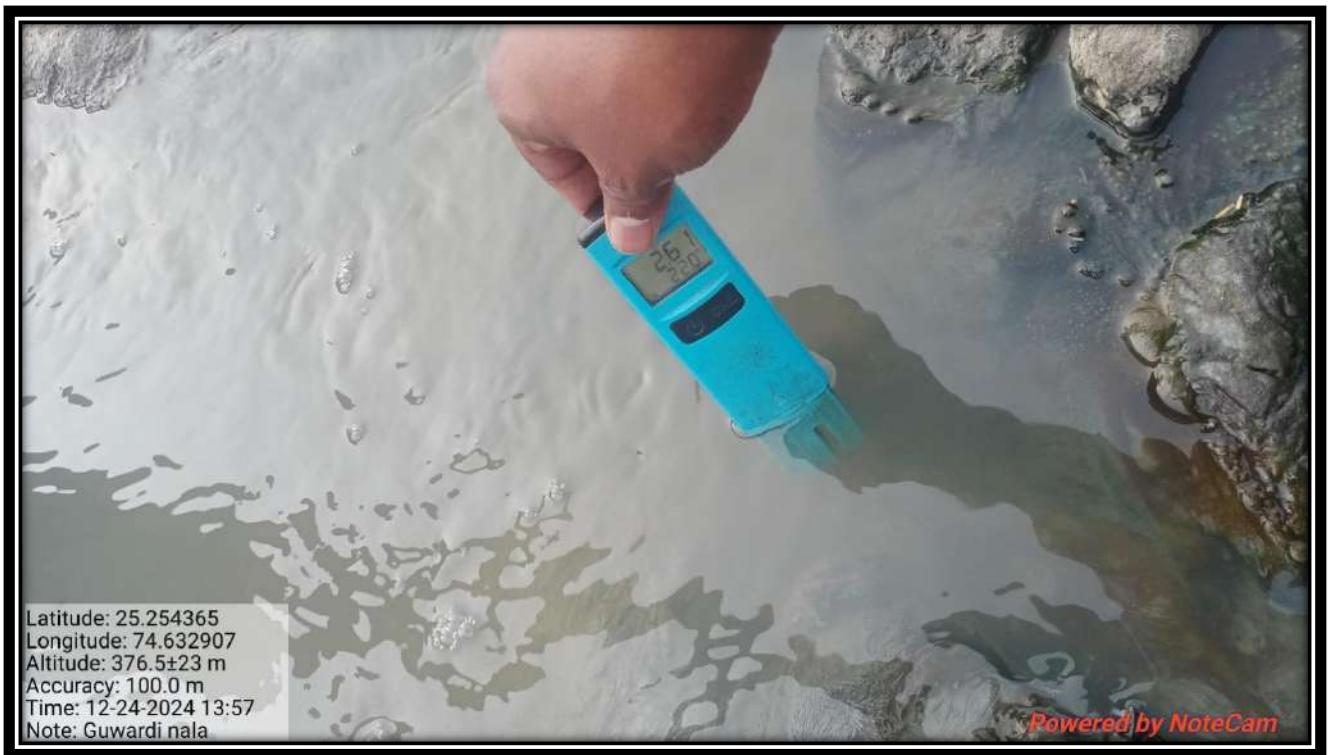
Figure 17 TDS of flowing water at Banas River

During the visit at check point no 6, Banas river, it was observed that no traces of textile effluent, based on its typical appearance and smell, was observed either in flowing state or at accumulated state at checkpoint stretch area of river.

Further, to check the quality of water, TDS of both flowing water and accumulated water was measures and it was observed as 2610 mgpl and 3260 mgpl respectively.

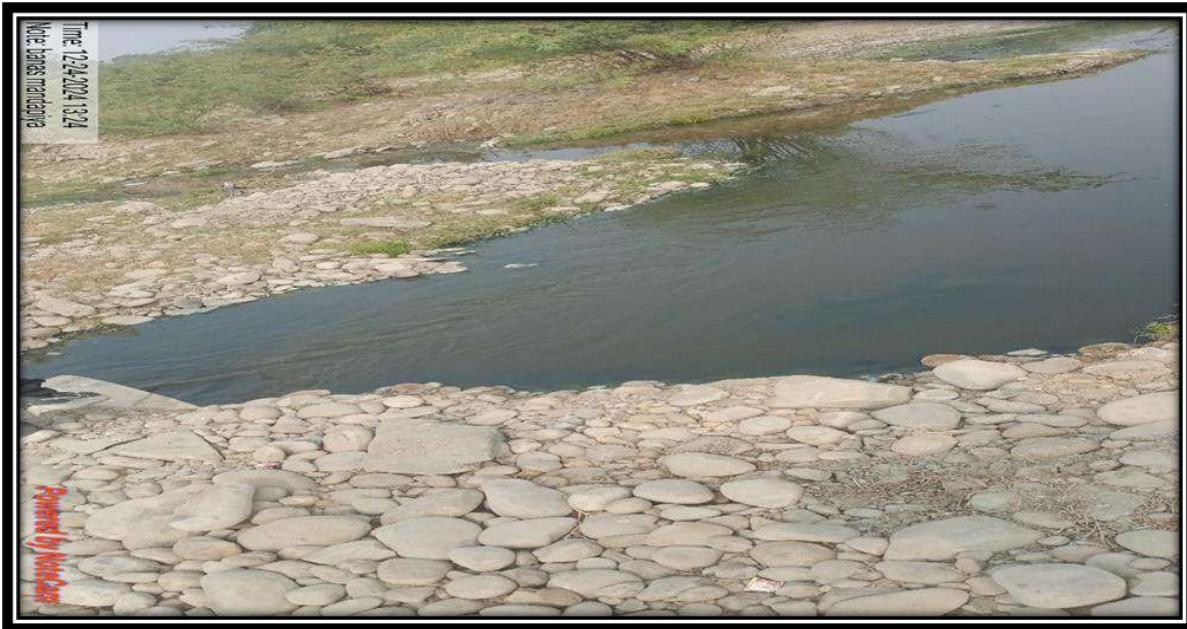
Figure 18 Appearance of Banas Water

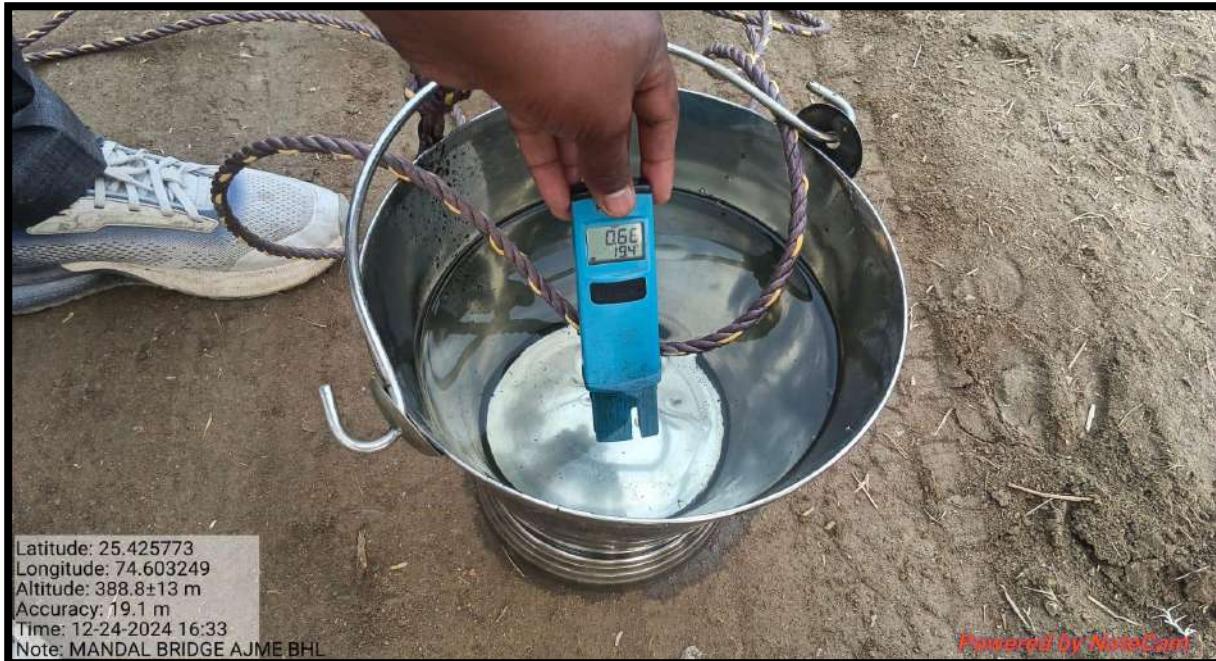
Figure 20- TDS at Kothari River

As such primarily, it can be inferred from the above, that though units have not discharged any effluent into any drain. However, M/s Sulzer Processors sprayed the High TDS Effluent, outside the premises, on its own land.

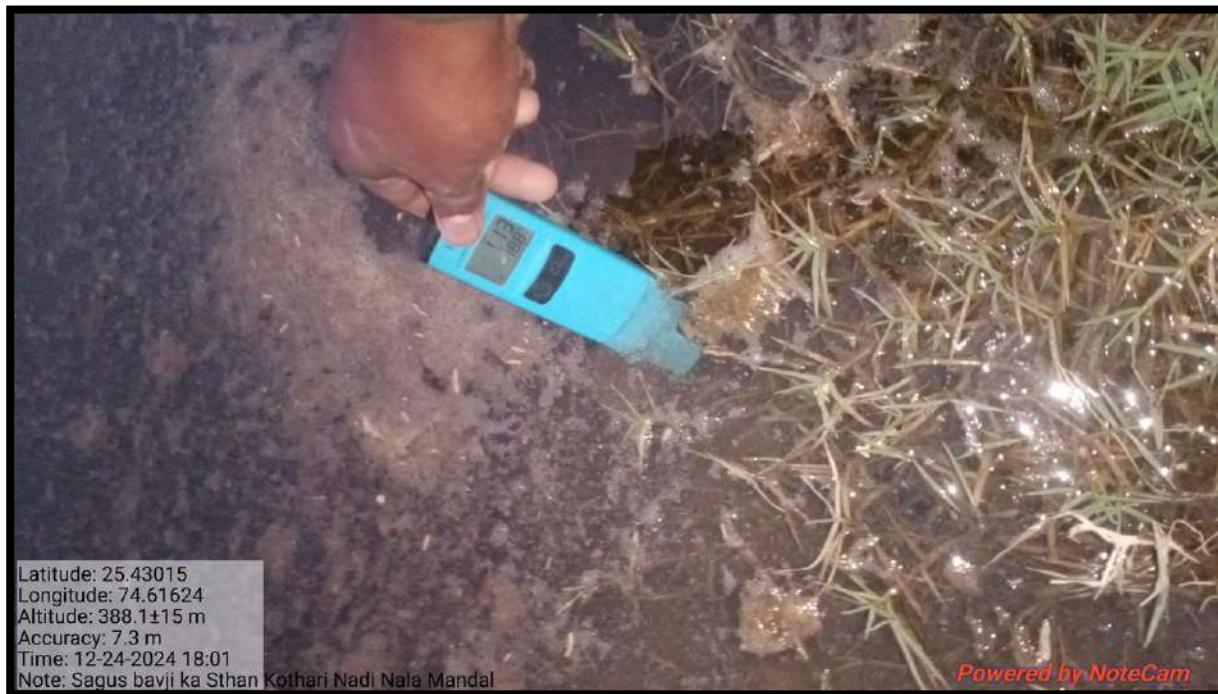
Figure 21 TDS Measurement at Check Point No 8- Chhatri ka Kheda

Further, **Check Point No 8**, drain located at Chhatri ka Kheda, leading towards Kothari River, downstream of Saileela Processors was also checked. During the visit, no significant flow was observed in the drain at check point no 8. TDS of accumulated water in the drain was checked and it comes out to be 1130 mgpl.
