Sub.:- Regarding News report relayed on local channels in the name of Lok Jeevan & India News, on dated 10.04.2026.

In reference to above subject, kindly find enclosed the Complaint Verification Report dated 10.04.2026, along with observations dated 13.04.2026, regarding the alleged discharge of effluent into Guwardi and Mandapiya Nalla from M/s Anant Syntex Pvt Ltd at Chittorgarh Road, Bhilwara.

Inspection Report

1.	a. Name of the Industry	M/s Anant Syntex Ltd
	b. Address of the industry	Post Box No. 107, Village - Gathaila Khera, Chittorgarch road, Bhilwara, Rajasthan

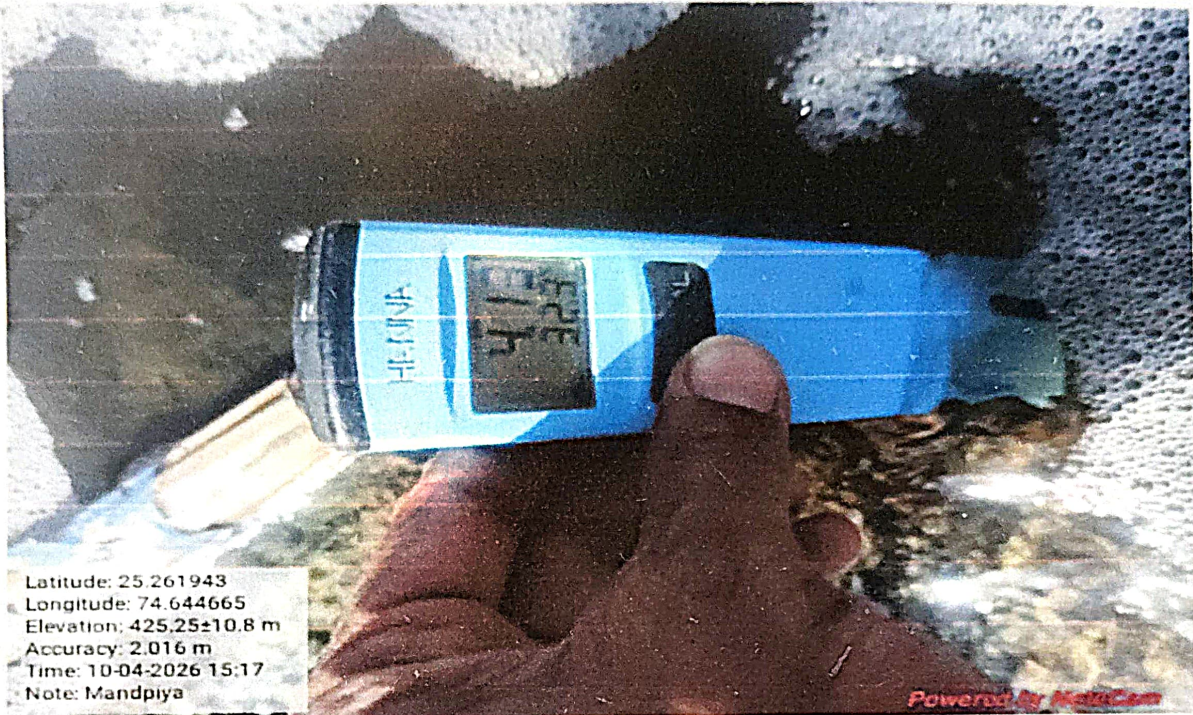
4. To verify the claim made by the villagers, location was inspected and it was observed that a pipeline had been laid in the area, through which high TDS effluent was being discharged. It was further observed that junction arrangement fitted with nuts and bolts had been installed, in the pipeline, and high TDS effluent was found accumulated around this arrangement in huge quantity, which circumstantial signifies possible discharge of effluent from this place, which eventually raised the overall TDS of the flowing water to the level 4130 ppm in Nalla at Mandapiya Bridge.

Figure 1. Effluent check on dated 10.04.2026 at Mandapiya unikt

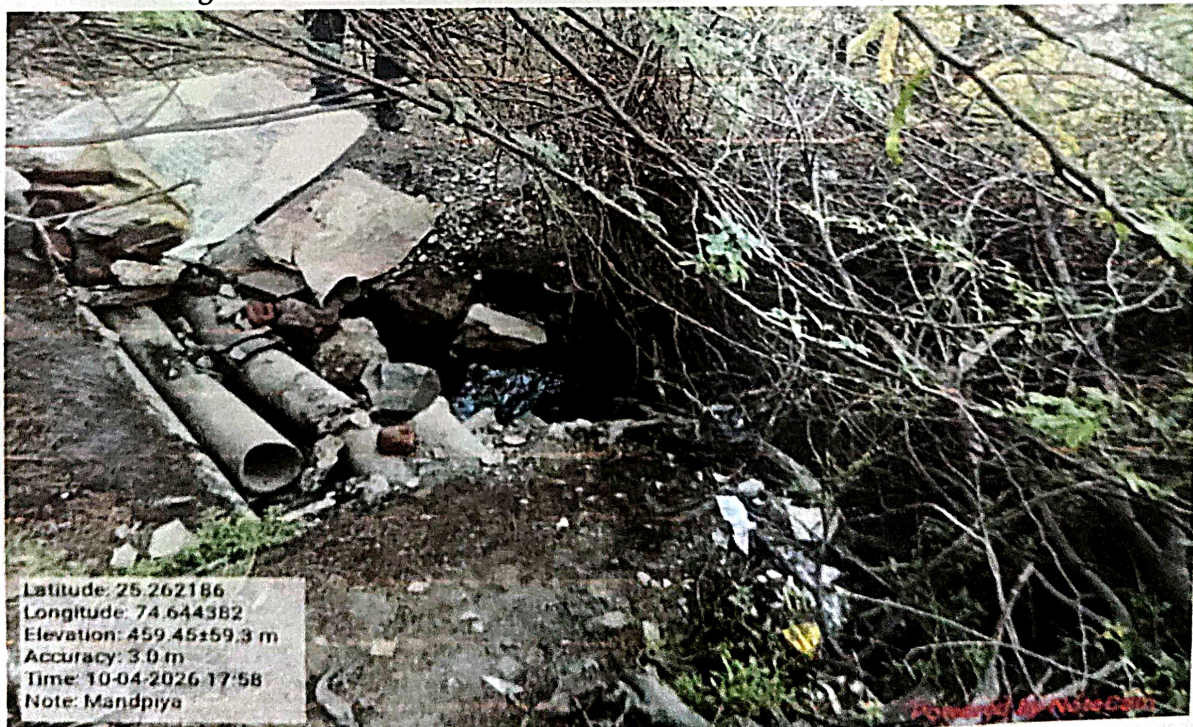
Figure 2. Nut Bolt arrangement attached with Pipe line at Mandapiya unikt of M/s Anant Syntex Ltd

In view of above observations, there is high possibility that, discharge of effluent, through the fresh water line has been done by this unit. Further, condition of the treatment system installed by the unit were also not found to be working efficiently. Therefore, it is proposed to initiate action against the unit in accordance with the law , which may include imposition of EC, along with the directions to the unit to submit a time bound action plan for :-

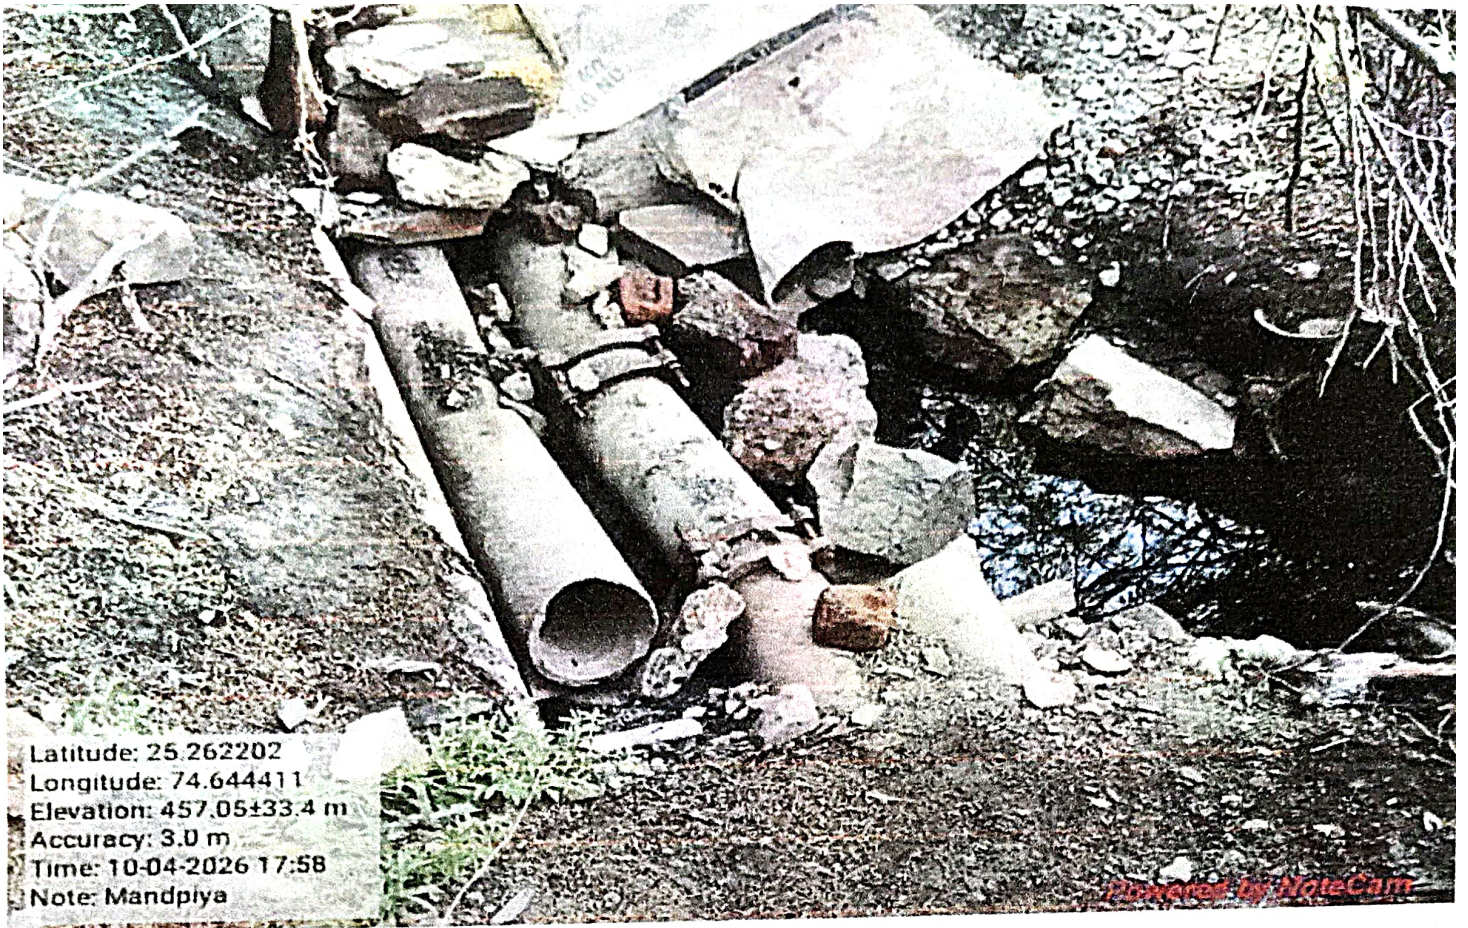
Figure 3. Nut Bolt arrangement attached with Pipe line at Mandapiya unikt of M/s Anant Syntex Ltd

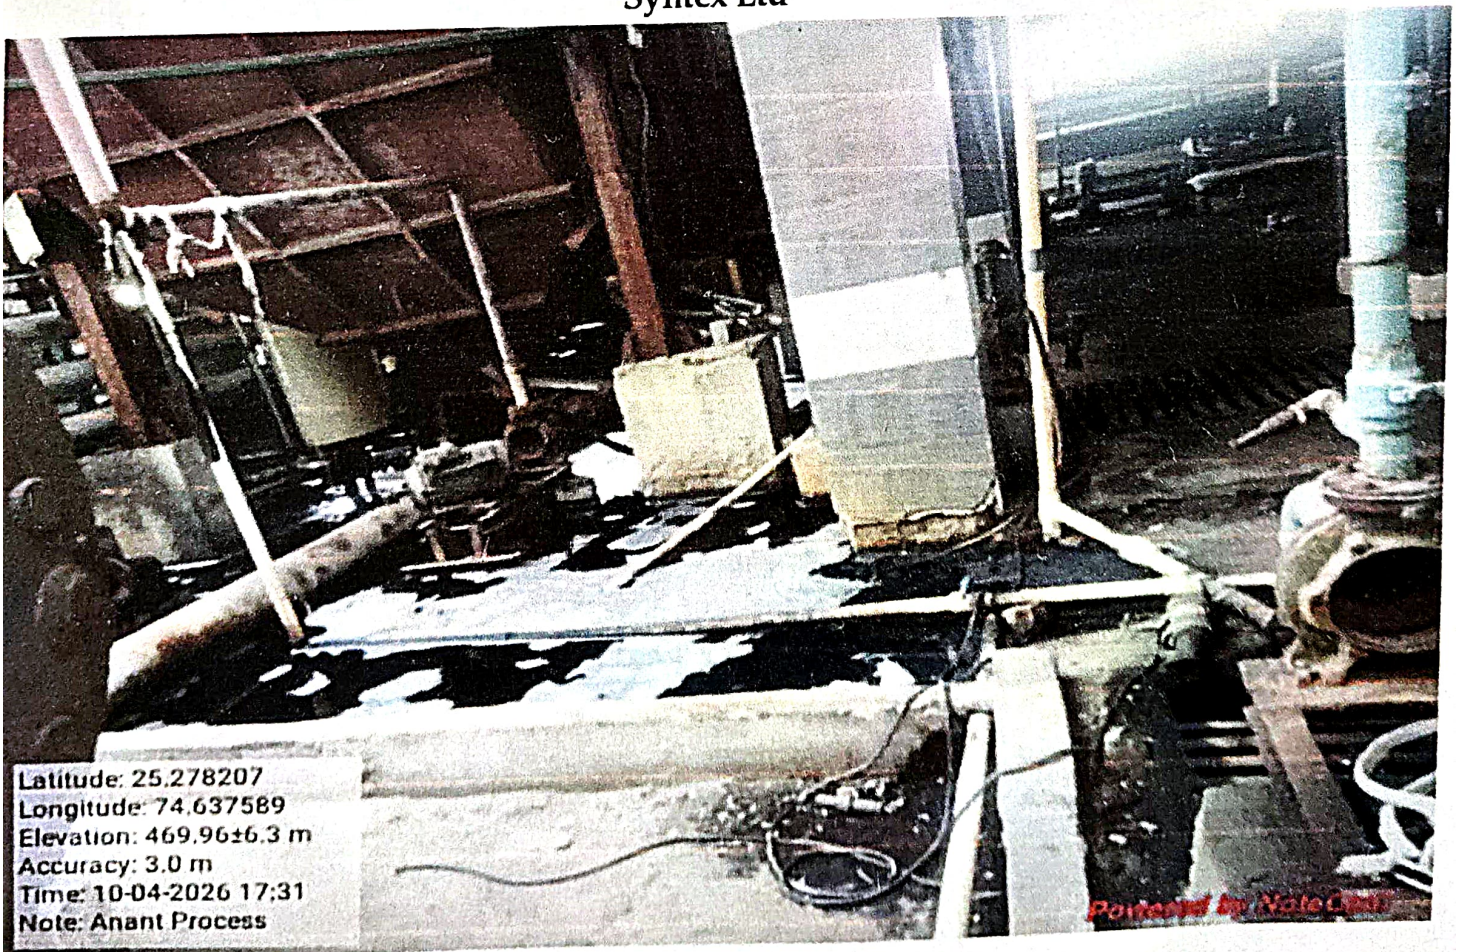
7. In continuations of the above, the inspection of M/s Anant Syntex Ltd was carried out after this, and effluent was found scattered/spread within the premises. The Reverse Osmosis (RO) plant was observed to be in a leaking condition, and poor housekeeping practices were found at the site.

Figure 4. High TDS effluent accumulated at M/s Anant Syntex Ltd

10. This overall impact regarding condition of ETP and RO , might affect the overall efficiency of treatment system and representative was directed to renovate the complete system including leakages of RO /Overflowing of tanks /Removal of Flexible Lines etc within 15 days time and report to the office.
11. Along with that sludge drying area of the unit was also filled up with sludge and space seems to be insufficient for proper drying of sludge. To this unit representative has informed that, they are in process of purchasing the sludge dryer and order for the same has been placed. Representative was directed to expedite the process.

- a. Renovations of all civil tanks being used for treatment purpose.
- b. Removal of all flexible pipelines from ETP/MEE/ATFD area and replace them with permanent lines.
- c. Rectify all the leakages exists in the system.
- d. Improve the House Keeping of the premises.

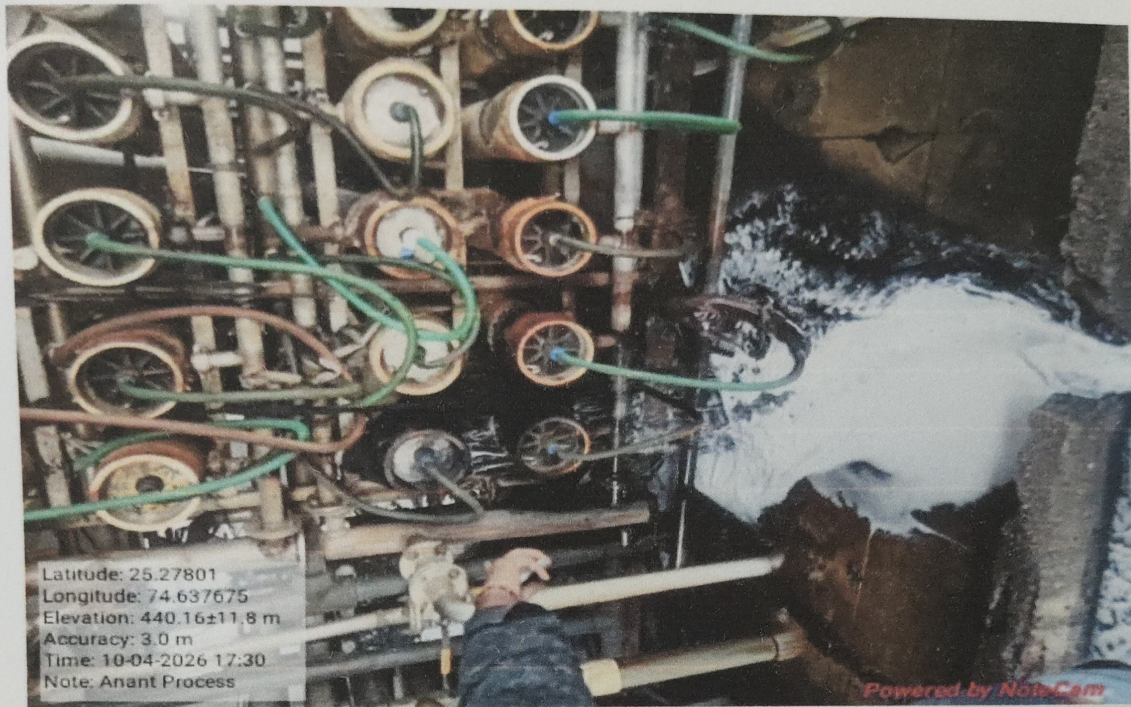
Figure 5. Leakage of RO plant

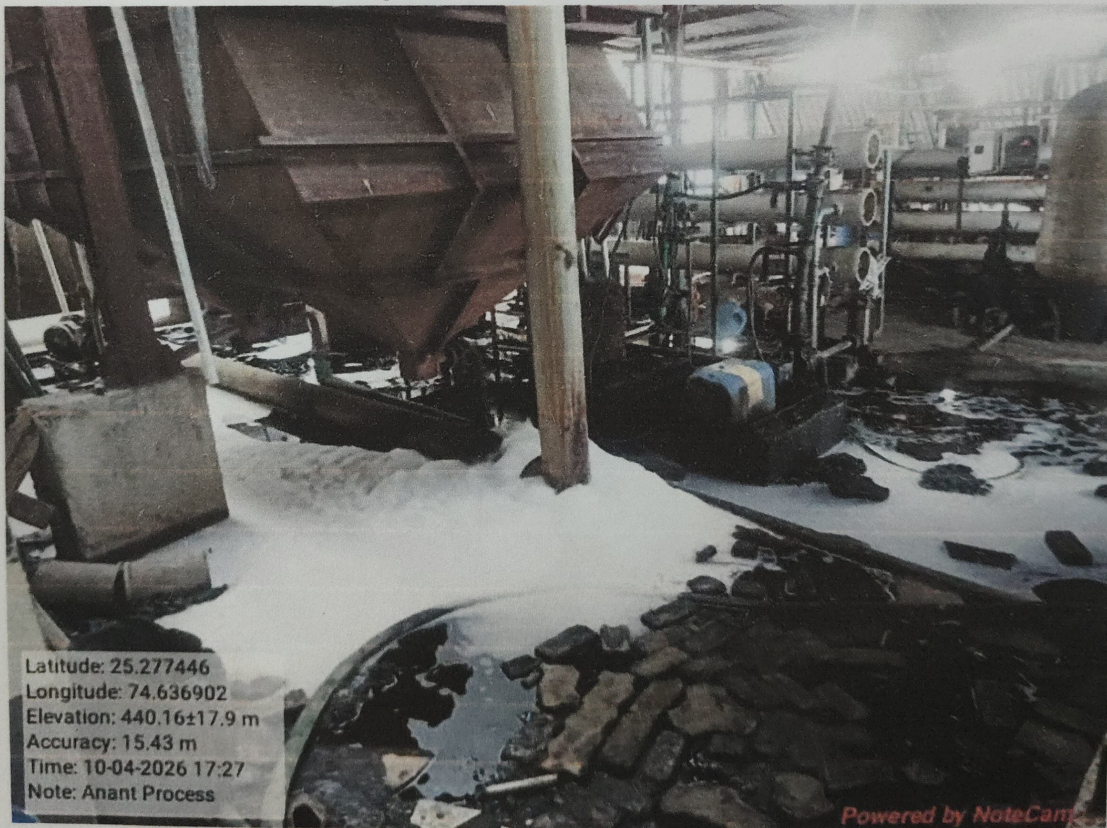
8. Tanks located in the premises used for equalization and other purposes were found to be either in leaking condition or overflowed.
9. Further, many flexible pipe lines were also observed within the premises, despite repeated directions passed by this office, to remove the same. These Flexible pipelines may indicates, the possibility of effluent may be routed back to the lines during night hours.

Figure 6. Flexible Pipeline found near effluent accumulated at M/s Anant Syntex Ltd

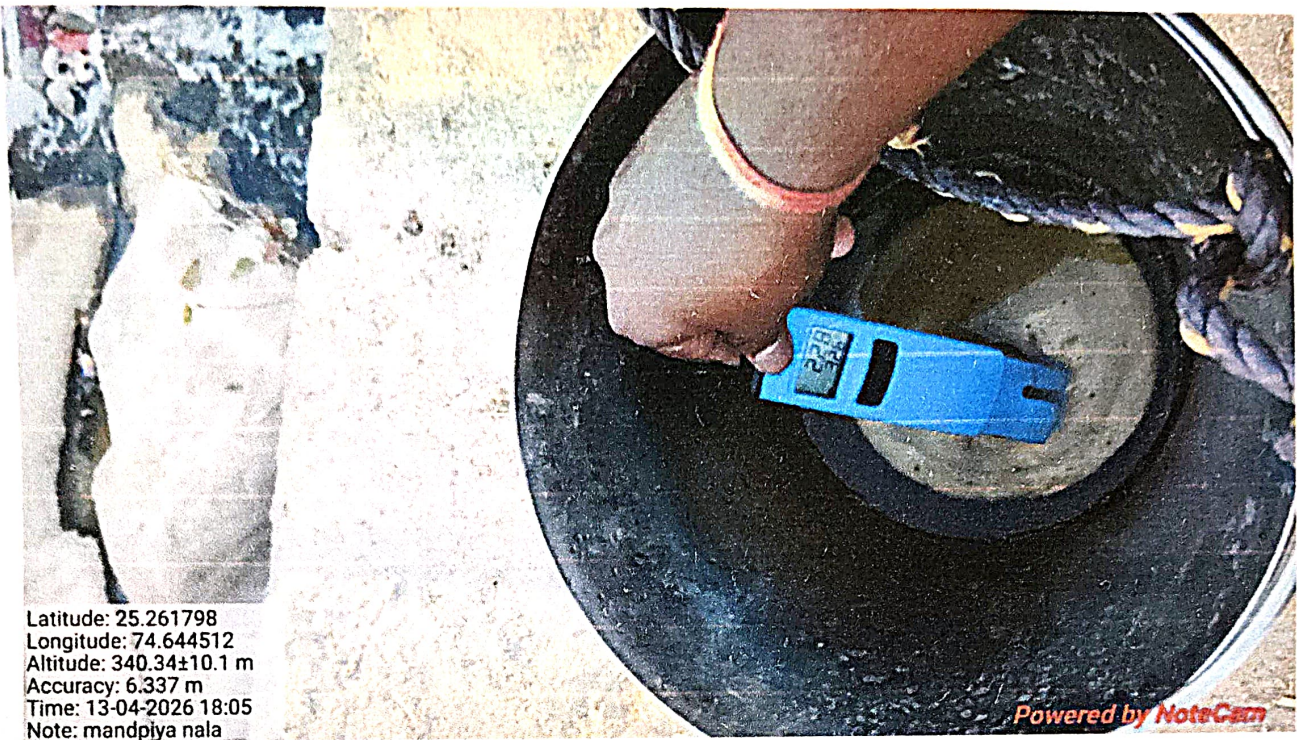
1. Aforesaid site was again visited by the Board official on dated 13.04.2026 and mild flow was still observed at Mandapiya Nalla. However, appearance of the Nalla this time observed to be less blackish as compared to 10.04.2026. TDS of flowing water from Mandapiya Nalla was also checked, and the same was found to be 2280 ppm, which may be due to the reason, as unit might not have discharged effluent after 10.04.2026 into the Nalla and same was reduced to 2280 ppm from 4130 ppm after dilution of domestic water of low TDS flowed in the last 2-3 days.
2. Unit has rectified the area around the pipeline (Nut bolt arrangement) at Mandapiya Nalla. (GPS coordinated photographs enclosed for reference)

Figure 7. TDS checked at Mandapiya Unikt & same was found 2280ppm.

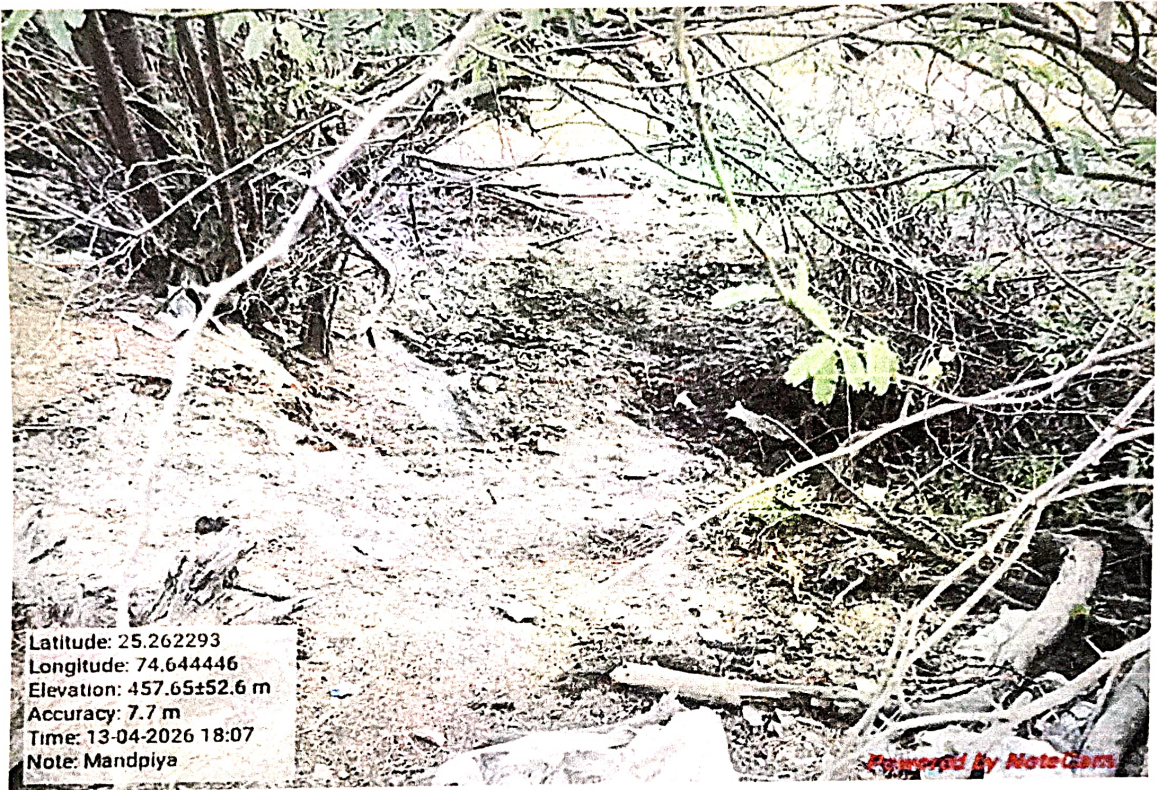
Figure 9. Rectified Nut Bolt arrangement attached with Pipe line at Mandapiya unikt of M/s Anant Syntex Ltd
