Sub.: Forwarding of complaint verification report of M/s Sangam India Ltd,  
Village - Atun, Chitorgarh Road, Bhilwara.

## Site Verification Report

In compliance of direction received from Regional Officer, regarding verification of issue raised telephonically by complainant Sh. Ghanshyam Mali & Sh. Vijay Mali on 04.08.2026, regarding discharge of industrial effluent from M/s Sangam India Ltd, Near Village Atun, Chitorgarh Road, to their vacant land/ Plot adjacent to backside boundary wall of the industry.

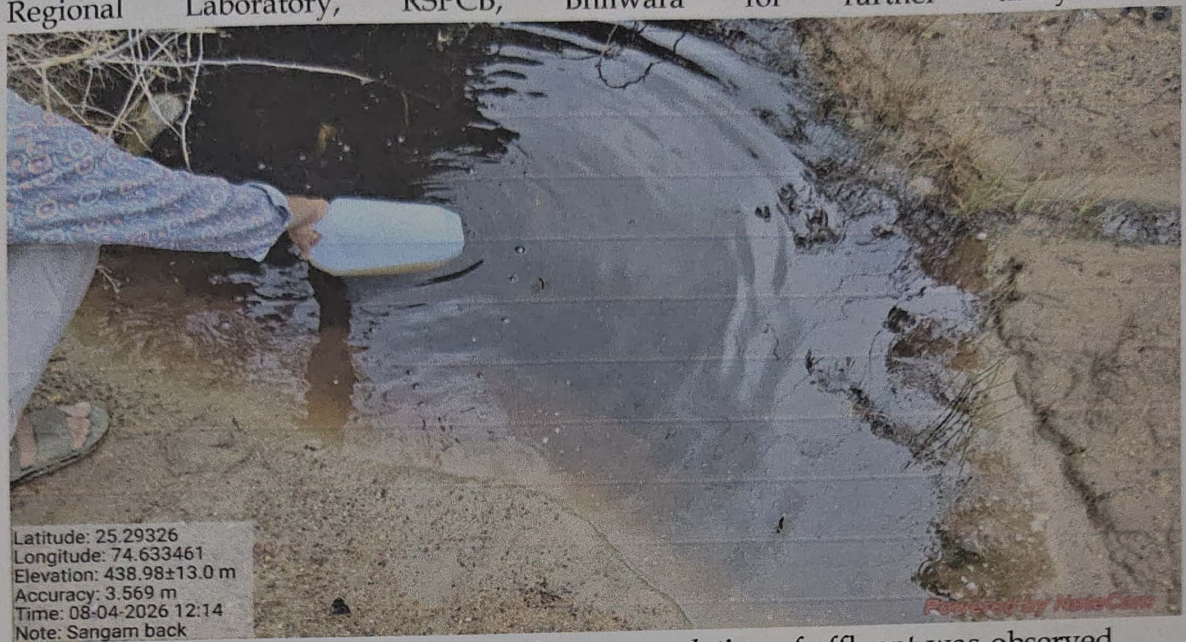
3. Effluent Sample from the site where same was accumulated and complainants identified as its agriculture field was collected and Sample was submitted to Regional Laboratory, RSPCB, Bhilwara for further analysis.

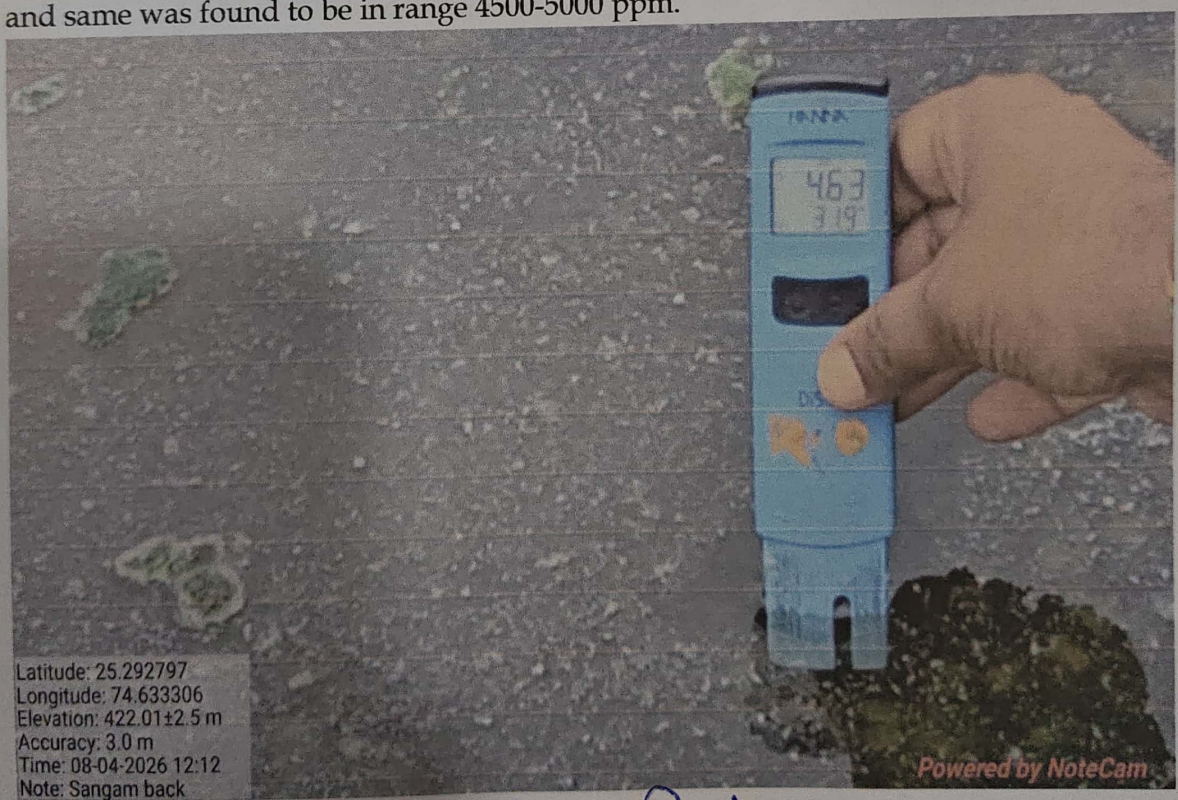
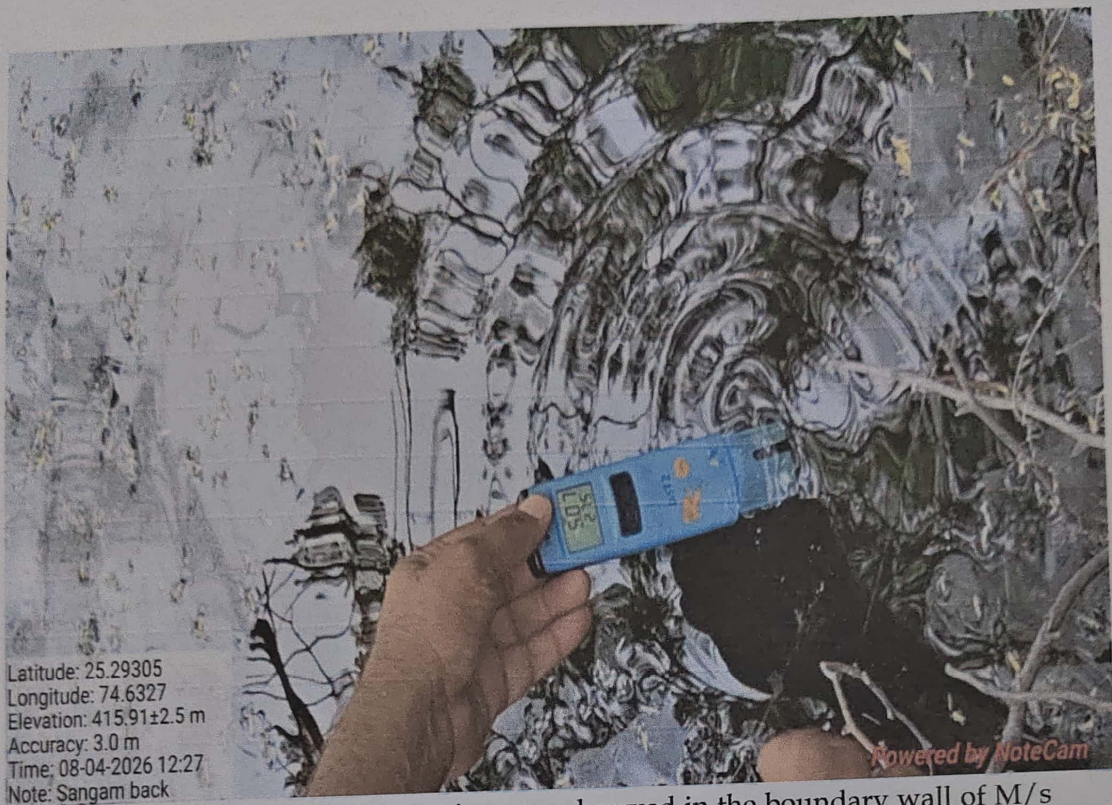
4. In the same field, moving further another accumulation of effluent was observed and TDS of the effluent was measured on-site using a Handy HANNA TDS meter and same was found to be in range 4500-5000 ppm.

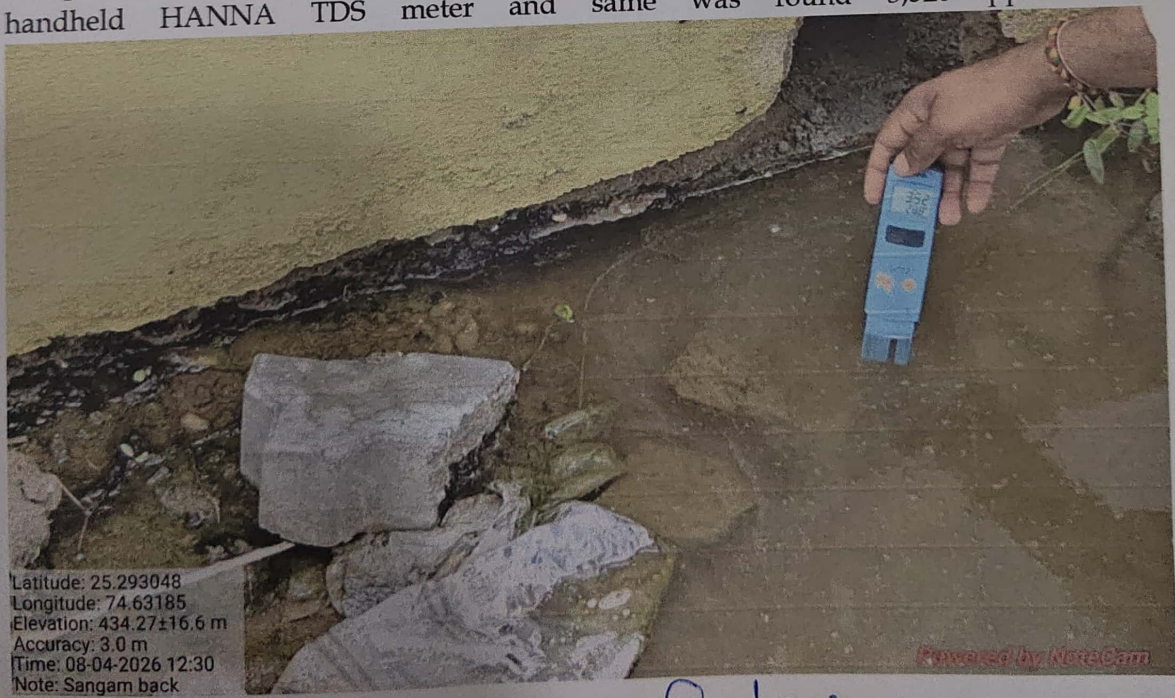
5. During the inspection, a hole/opening was observed in the boundary wall of M/s Sangam Venture, through which effluent appeared to have discharged outside the unit premises. The TDS of the water measured near the said opening/Hole using a handheld HANNA TDS meter and same was found 3,520 ppm.

Recommendations: In view of above, as it is evident that unit has discharged untreated effluent outside the premises and other site conditions such as presence of flexible pipes/ filled up RO Reject Tank etc, it is proposed to initiate suitable action against the unit under provisions of Water Act industry imposition of EC against unit.

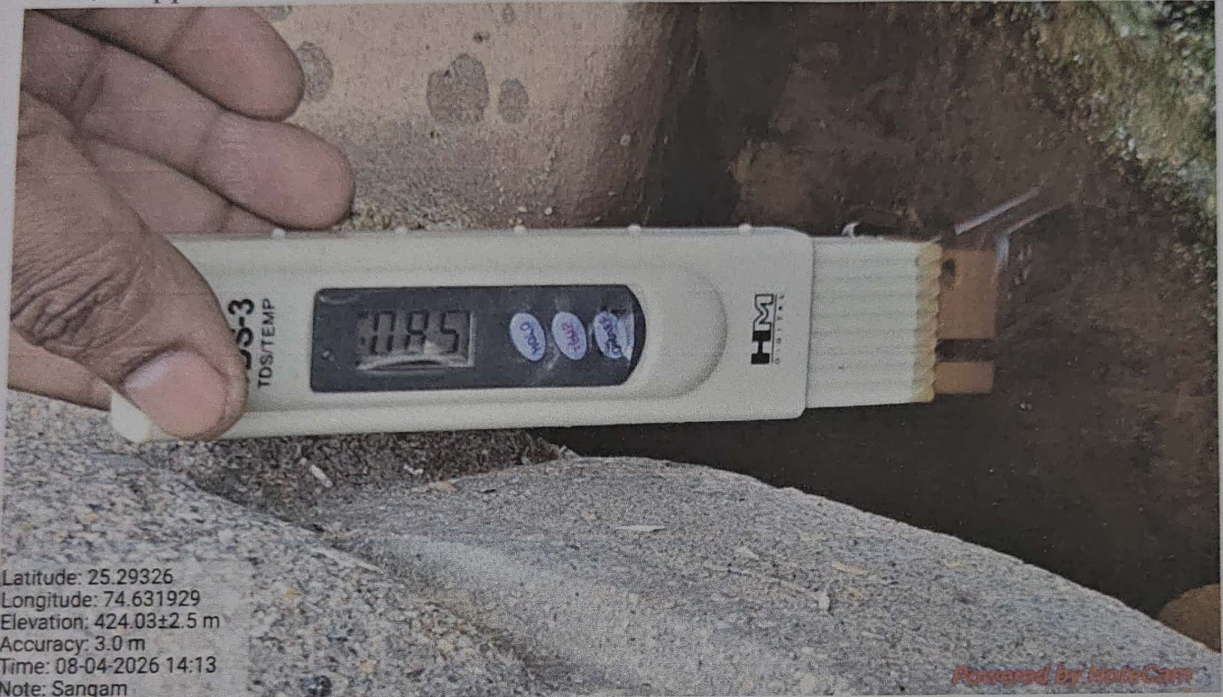
6. The area between M/s Sangam Venture and M/s Sangam Weaving Unit was also inspected. It was observed that a boundary wall had been constructed between the two units. During the inspection, high TDS water was found accumulated beneath the cement pole boundary wall. The TDS of the accumulated water was measured on-site using a HM Digital (TDS - 3, TDS/TEMP) TDS meter (TDS meter was procured by unit representative of M/s Sangam Venture) and same was found to be 58,000 ppm.

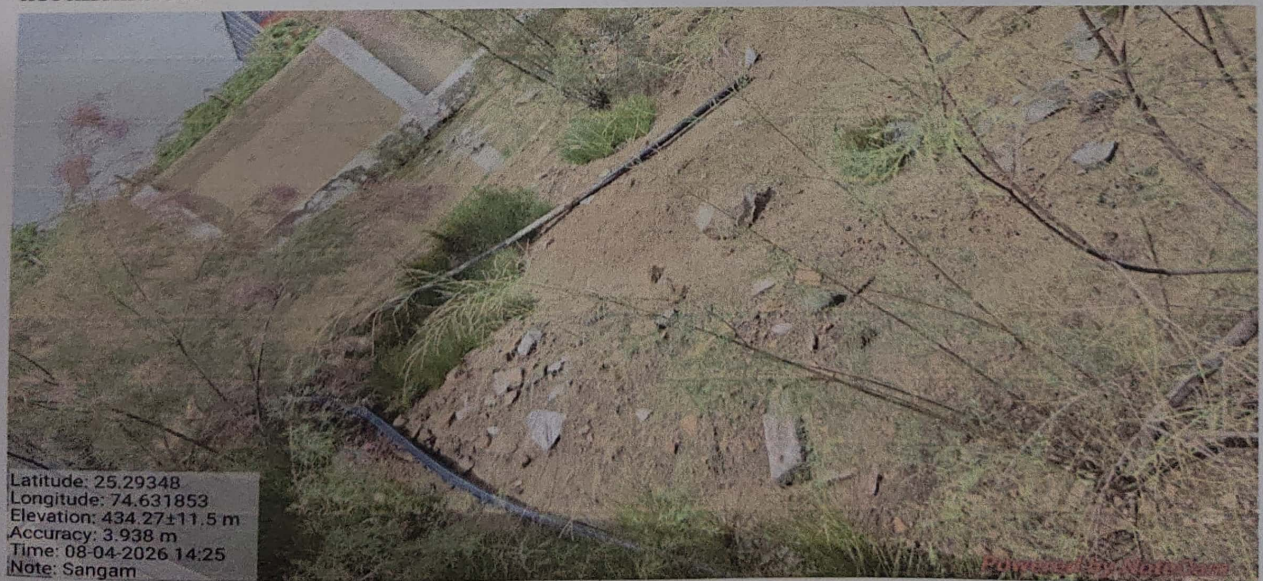
7. It was further observed that a flexible pipeline was lying near the boundary wall between M/s Sangam Venture and M/s Sangam Weaving Unit. The flexible pipeline was found in close proximity to the location where high TDS water had accumulated.

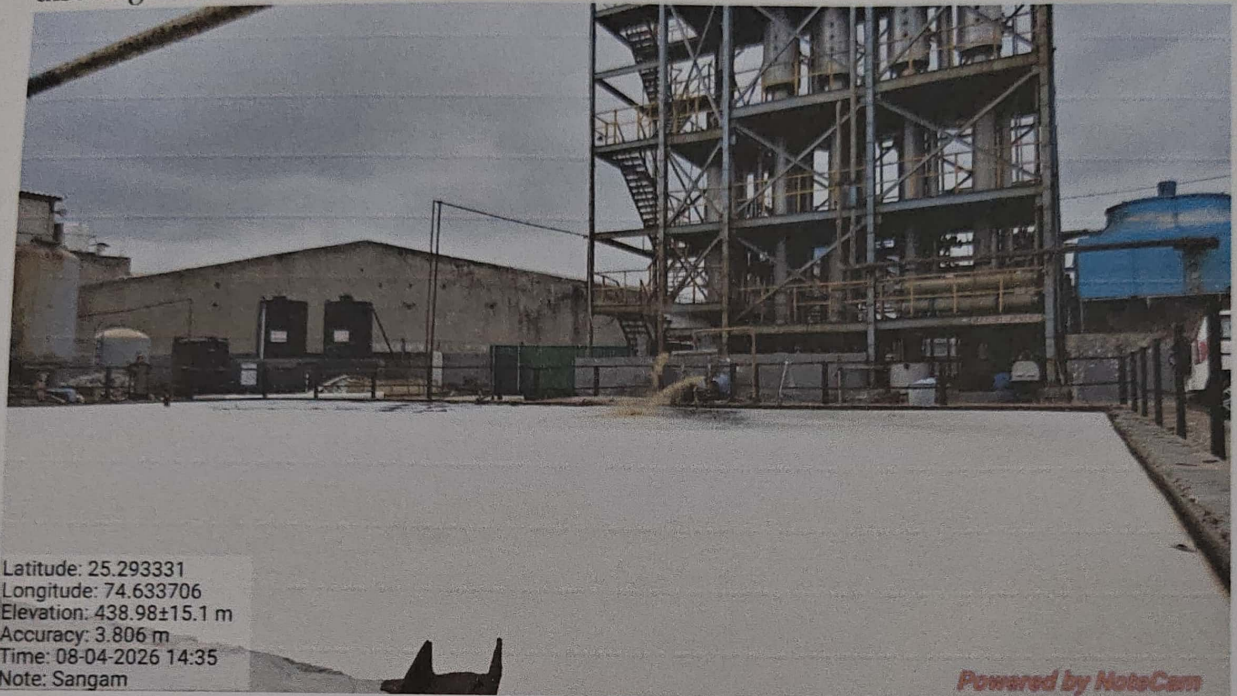
2. In the vicinity of the said Vacant plot/ land, inside the industry premises the Multiple Effect Evaporator (MEE) Plant and the RO Reject Collection Tank were

found established and reject holding tank was almost filled & a creek was found in the same structure and reject was flowing it and also accumulated.

8. Thereafter, the premises of M/s Sangam India Ltd. was inspected. During the inspection, the RO Reject Tank was found to be almost filled with effluent. There is high possibility that, in case of any rain incident, and also a crack was found in the structure this reject may gets overflowed discharged through rain water & gets discharged outside the unit premises.
